**SERVICE BULLETIN NO.639**

<b>SUBJECT:</b>	Proper installation of impulse couplings
<b>REASON FOR BULLETIN:</b>	To modify, confirm and stress the importance of proper installation procedures of impulse coupling assemblies
<b>EQUIPMENT AFFECTED:</b>	All TCM & Bendix S-20, S-1200, D-2000 and D-3000 series magnetos with impulse couplings as installed on TCM, Lycoming, Franklin and other manufacturer's engines.
<b>COMPLIANCE:</b>	<b>MANDATORY AT TIME OF INSTALLATION OF ANY BENDIX/TCM IMPULSE COUPLING ASSEMBLY</b>

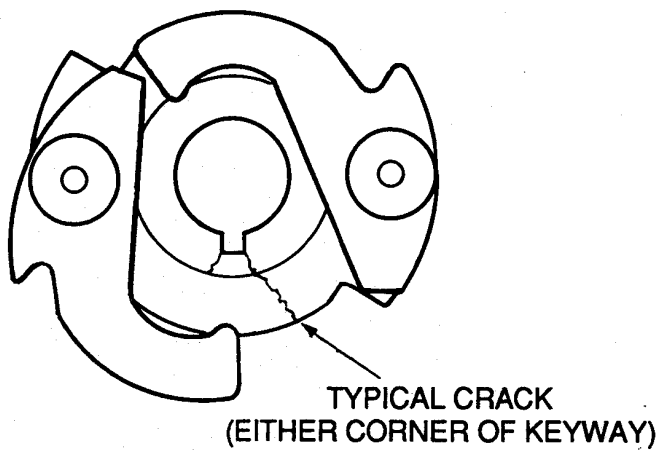
**FIGURE 1**

Field reports indicate that there have been instances in which the impulse coupling cam assemblies have cracked upon installation. See Figure 1. Cracking can be caused by improper installation procedures which may result in coupling assembly damage or potential engine failure.

4. Using a CALIBRATED torque wrench, tighten nut to 180 in-lbs. Install and secure new cotter pin. If unable to install and secure new cotter pin, increase torque gradually to align the first available slot in the castellated nut.

**WARNING...Under no circumstances should you exceed 300 in-lbs. torque. Any impulse coupling that is damaged in any way during installation must be replaced.**
