CRITICAL SERVICE BULLETIN

CSB 02-2C

SUBJECT: STARTER ADAPTER SHAFT SEAL INSPECTION

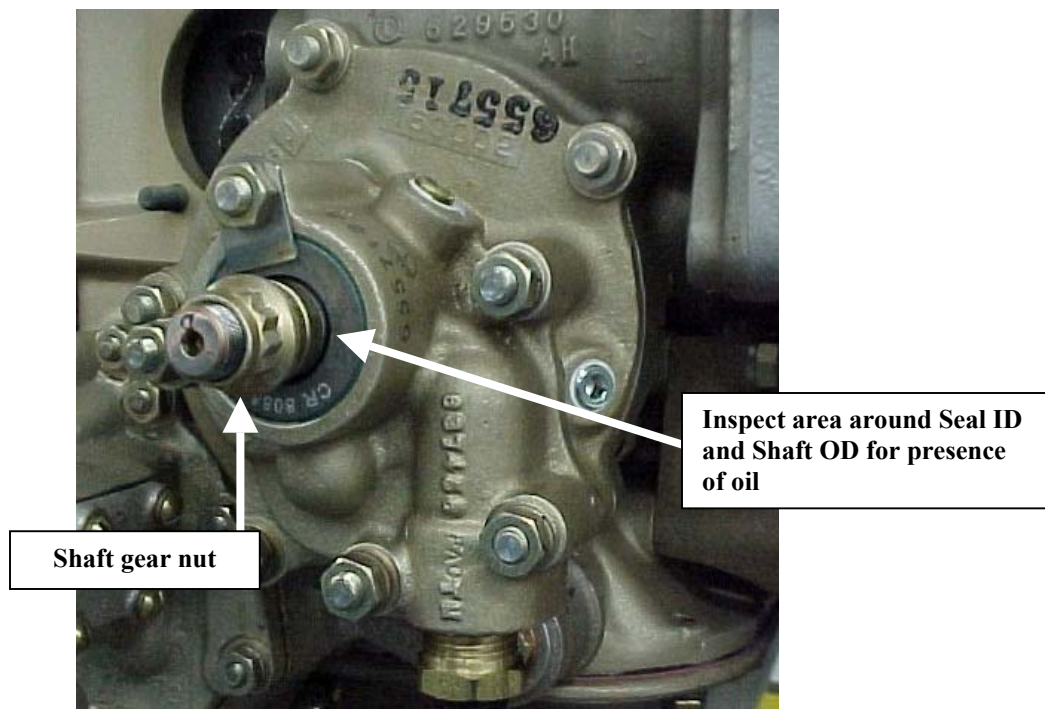
FIGURE 1
P/N 642087A XX Starter Adapter

Service Bulletin does not apply. If the starter adapter installed on your engine does have a shaft extending past the rear cover of the starter adapter (Figure 1), inspect the area around the oil seal ID and the starter adapter shaft OD for the presence of oil that may indicate a shaft issue.

If there is oil present, determine if the starter adapter shaft gear has fractured by attempting to rotate, in a clockwise direction, the shaft gear using the correct size 12 point wrench or socket engaged on the shaft gear nut. Reference Figure 1.

If the shaft gear nut does not readily turn or results in the engine and propeller rotating, the shaft gear is not fractured. Determine the source of the oil and take appropriate correction action.

If the shaft gear turns with a minimal amount of force, the shaft gear is fractured and the starter adapter will require replacement prior to further flight.

Starter adapter replacement to be accomplished in accordance with the applicable engine maintenance or overhaul manual.

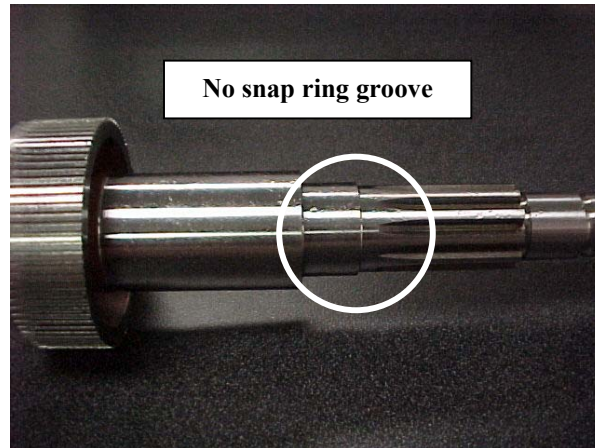
FIGURE 2
655711 Shaft Gear

Teledyne Continental Motors has verified the breakage of 7 part number 649866 starter adapter shaft gears. The fractures originate in the machined circlip groove forward of the shaft gear oil seal installed in the scavenge pump housing. Analysis of the fracture area indicates initiation resulted from misalignment of the scavenge pump housing to the starter adapter cover.

The starter adapter shaft gear P/N 655711 replaces shaft gear P/N 649866. The P/N 655711 shaft gear does not have the snap ring groove machined just aft of the first shoulder as noted in Figure 2.

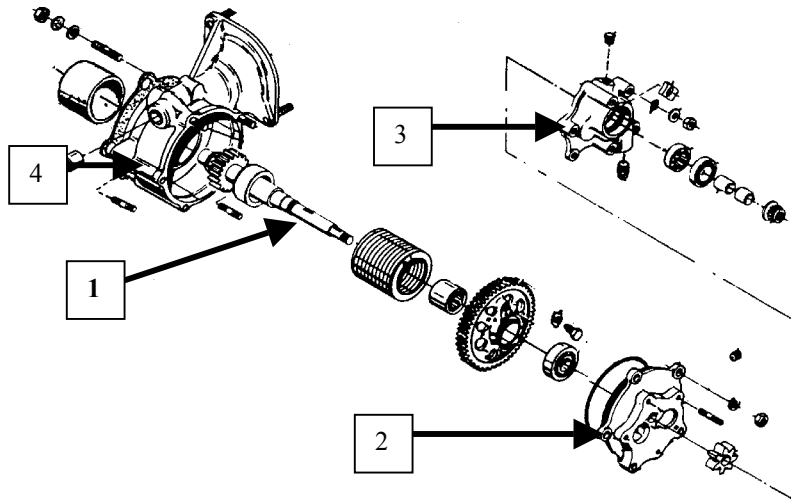
FIGURE 3
P/N 642087A "XX" Starter Adapter

TCM has implemented a production change to the starter adapter cover, scavenge pump housing and starter shaft gear. Refer to FIGURES 1, 2 and 3. The starter adapter cover P/N 640747 has been replaced by P/N 655714 cover. The P/N 655714 contains two alignment dowels, one at the 5 o'clock stud and another at the 7 o'clock stud. The scavenge pump housing P/N 652019 has

been replaced by the P/N 655715A1 housing. The P/N 655715A1 housing has the mating 5 o'clock and 7 o'clock stud holes machined to accommodate the alignment dowels.

All starter adapters overhauled or repaired in the field must be assembled using the parts noted in Figure 3, or subsequent part numbers. Shaft gear P/N’s 640745, 640803, 649882 and 649866 must be removed from service and replaced with P/N 655711 or subsequent part number shaft gear. P/N 655714 (Cover- item 2 Figure 3) and P/N 655715 (Housing, Scavenge Pump- item 3 Figure3) are manufactured with alignment dowels and must be used together. Do not use either P/N 655714 or P/N 655715 with previous superseded mating parts.
