TELEDYNE CONTINENTAL ® AIRCRAFT ENGINE  
**CRITICAL SERVICE BULLETIN**  
 Compliance Necessary To Maintain Safety

**CSB 04-5A**  
 TECHNICAL PORTIONS  
 FAA APPROVED

**CSB 665A**

**SUBJECT: MAGNETO CAPACITOR P/N 10-400615 INSPECTION AND REPLACEMENT.**

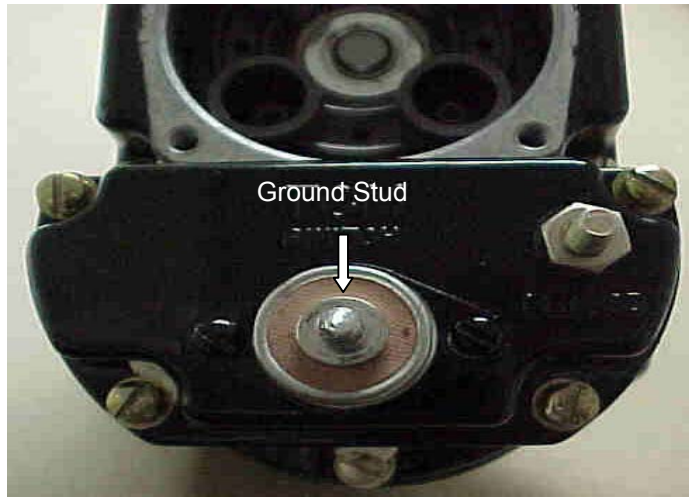
**Figure 1**

**PURPOSE:** TCM has identified a quantity of magneto capacitors part number 10-400615 which may have ground stud (also referred to as the P-Lead stud) threads that do not meet specification. This may allow the ground wire (P-Lead) to come loose, resulting in a hot magneto.

2. Remove the P-Lead from the capacitor ground stud. (Reference Figure 1)
3. Reinstall the P-Lead retaining nut and washer. Using a properly calibrated and certified torque wrench, torque the retaining nut to 27 inch-pounds.

4. If the P-Lead retaining nut can be torqued to 27 inch-pounds without slippage, no further action is required. Remove the retaining nut and reinstall the P-Lead. Torque the retaining nut to 15-17 inch-pounds. Make a log entry in the engine and airframe logbooks stating compliance with this bulletin.

5. If the retaining nut cannot be torqued to 27 inch-pounds, the capacitor must be replaced. Refer to section C or D of this bulletin, as applicable, for capacitor replacement procedures.

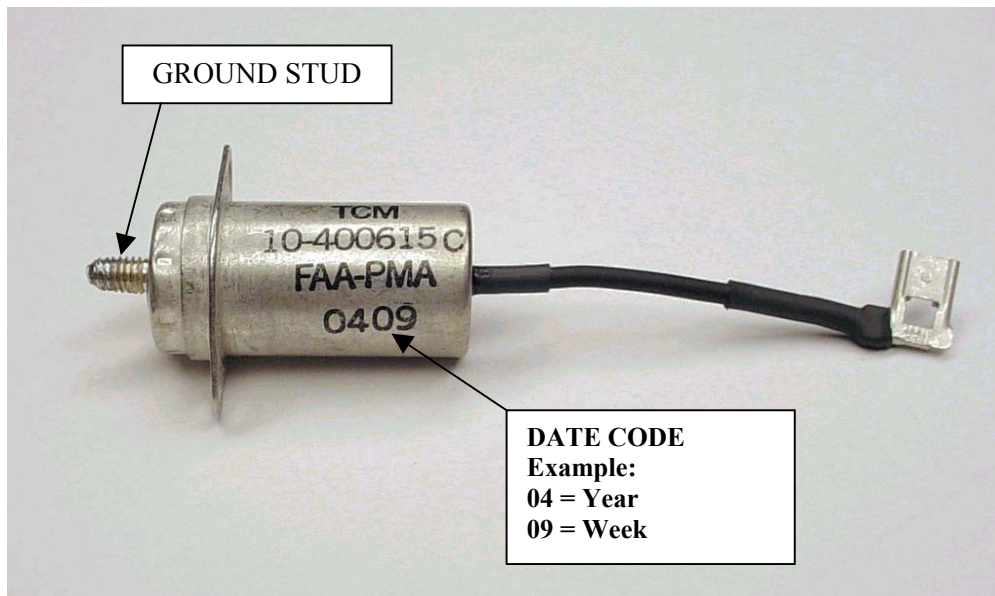
**FIGURE 2**

1. Examine each 10-400615 capacitor in spares stock for the stamped date code. (Reference Figure 2)
2. Dates codes of 03-44 through 04-17 must be removed from stock and returned to Teledyne Continental Motors under warranty through the TCM authorized distributor from which the affected capacitors were purchased.
3. Capacitors with date codes not listed above are not affected by this bulletin and cannot be returned for warranty consideration under this bulletin.
