**TELEDYNE CONTINENTAL® AIRCRAFT ENGINE
CRITICAL SERVICE BULLETIN**

**Category 2
CSB08-9A**
Technical Portions FAA
Approved(Supersedes
CSB08-9)

SUBJECT: Slick Service Bulletin SB3-08A

SUBJECT: Mandatory inspections on all Slick 4200/6200/4300/6300 and LASAR™ 4700/6700 magnetos

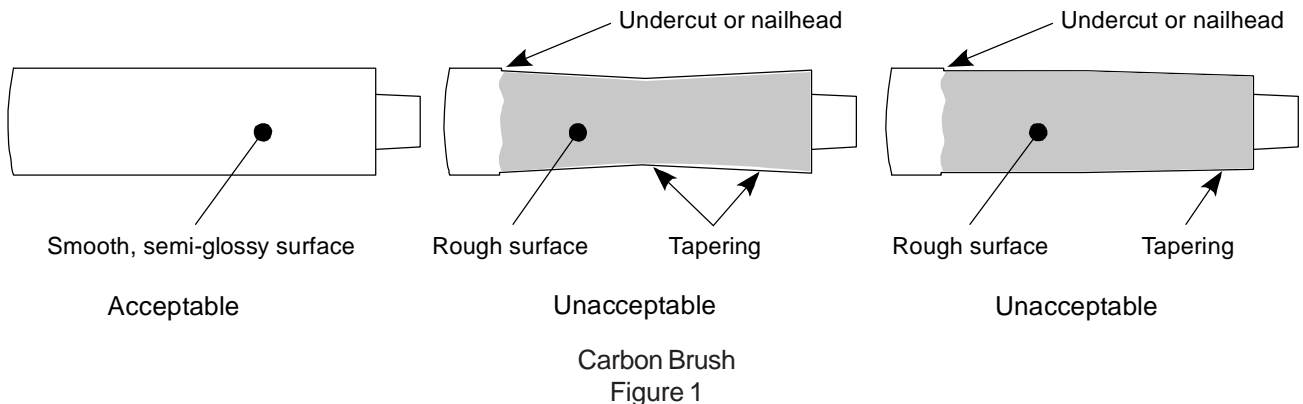
1. Use lighted magnification (4X minimum) to inspect carbon brush for rough surface and possible tapering. **REPLACE CARBON BRUSH THAT SHOWS ANY OF THE UNACCEPTABLE CONDITIONS SHOWN IN FIGURE 1 PER THE APPLICABLE MAINTENANCE AND OVERHAUL MANUAL.**

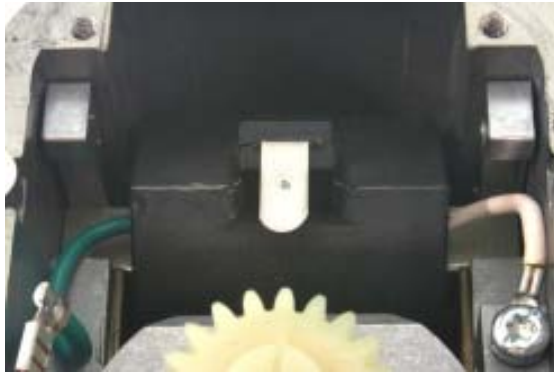
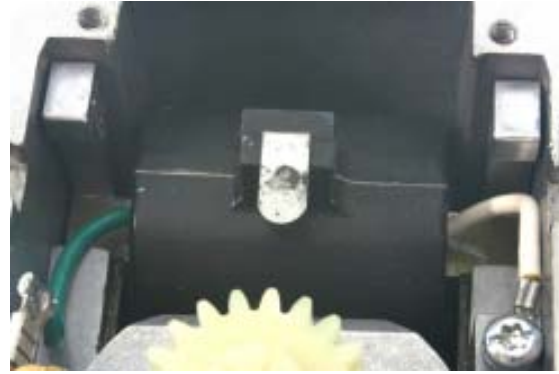
Evidence of Improper Wear of Carbon Brush
Figure 2

- Inspect coil tab for carbon residue coating left by carbon brush. See Figure 2. **REPLACE CARBON BRUSH PER THE APPLICABLE MAINTENANCE AND OVERHAUL MANUAL IF SUBSTANTIAL RESIDUE IS FOUND ON COIL TAB.** Use a cotton swab and alcohol to remove residue from coil tab, or replace coil if tab cannot be cleaned. Also inspect high tension coil tab for wear caused by carbon brush. Wear is indicated by a visible depression in the tab. If tab is worn, replace coil.

Acceptable

Unacceptable

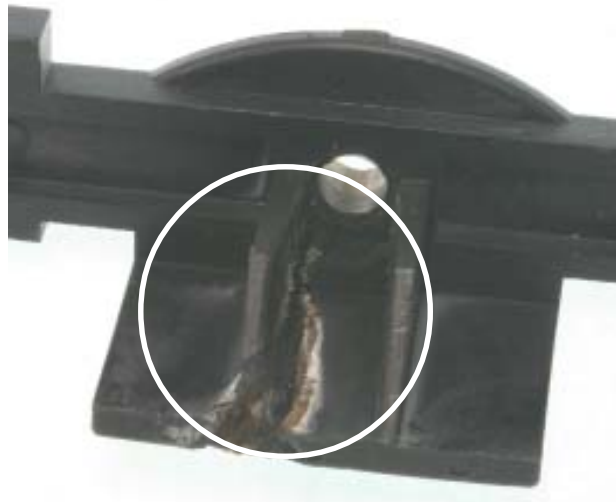
Bearing Bar
Figure 3

- Inspect bearing bar for evidence of brush residue contamination, burning, or arcing. See Figure 3. **REPLACE DISTRIBUTOR BLOCK ASSEMBLY PER THE APPLICABLE MAINTENANCE AND OVERHAUL MANUAL IF THERE IS ANY EVIDENCE OF ELECTRICAL ARCING OR BURNING.** The new bearing bar can be identified by either the manufacturer-dated packaging, or visually by noting the dams.

Unacceptable
(Developing bearing bar failure)

- If bearing bar does not show evidence of burning or arcing, clean and remove any normal residue per the applicable Maintenance and Overhaul Manual and reassemble into the magneto.

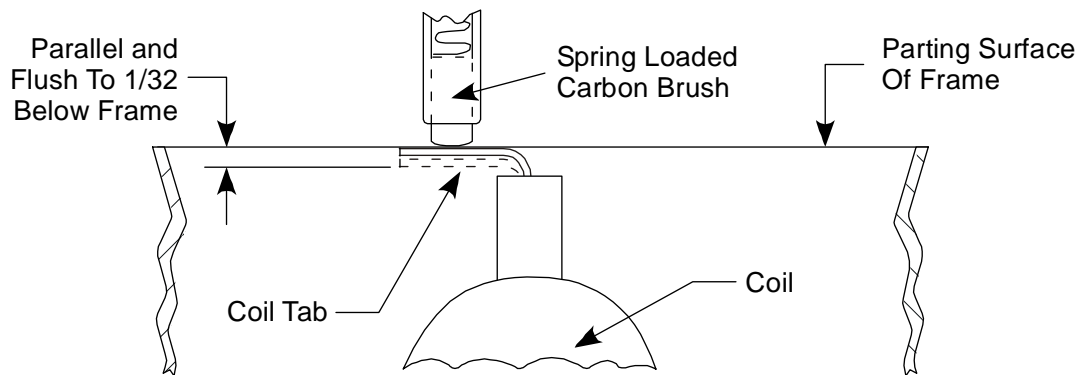
Coil Tab Positioning
Figure 4

CAUTION: IF THE COIL TAB PROTRUDES ABOVE THE MAGNETO FRAME, IT CAN MAKE DIRECT CONTACT WITH THE DISTRIBUTOR GEAR AXLE AND CAUSE THE MAGNETO TO MALFUNCTION.

- Prior to installing distributor block, make sure coil tab is parallel to and flush with frame mating surface to within 1/32 inch. See Figure 4.
