TELEDYNE CONTINENTAL® IGNITION SYSTEM
CRITICAL SERVICE BULLETIN
 Compliance Necessary To Maintain Safety

CSB 665A
 TECHNICAL PORTIONS
 FAA APPROVED

SUBJECT: MAGNETO CAPACITOR P/N 10-400615 INSPECTION AND REPLACEMENT.

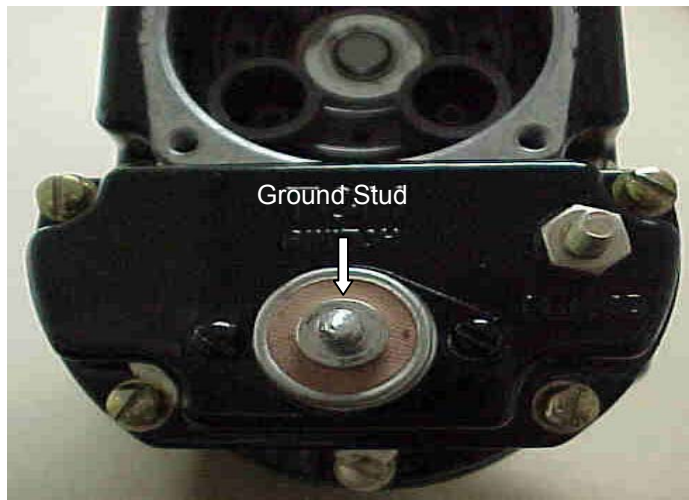
Figure 1

PURPOSE: TCM has identified a quantity of magneto capacitors part number 10-400615 which may have ground stud (also referred to as the P-Lead stud) threads that do not meet specification. This may allow the ground wire (P-Lead) to come loose, resulting in a hot magneto.

2. Remove the P-Lead from the capacitor ground stud. (Reference Figure 1)
3. Reinstall the P-Lead retaining nut and washer. Using a properly calibrated and certified torque wrench, torque the retaining nut to 27 inch-pounds.

4. If the P-Lead retaining nut can be torqued to 27 inch-pounds without slippage, no further action is required. Remove the retaining nut and reinstall the P-Lead. Torque the retaining nut to 15-17 inch-pounds. Make a log entry in the engine and airframe logbooks stating compliance with this bulletin.

5. If the retaining nut cannot be torqued to 27 inch-pounds, the capacitor must be replaced. Refer to section C or D of this bulletin, as applicable, for capacitor replacement procedures.
