**TELEDYNE CONTINENTAL<sup>®</sup> AIRCRAFT ENGINE**  
**CRITICAL SERVICE BULLETIN**  
 Compliance Necessary To Maintain Safety

**CATEGORY 2**  
**CSB96-8**  
 FAA APPROVED  
 SUPERSEDES M92-16.

**SUBJECT:** REPLACEMENT OF AIRMELT (NON-VAR) CRANKSHAFTS

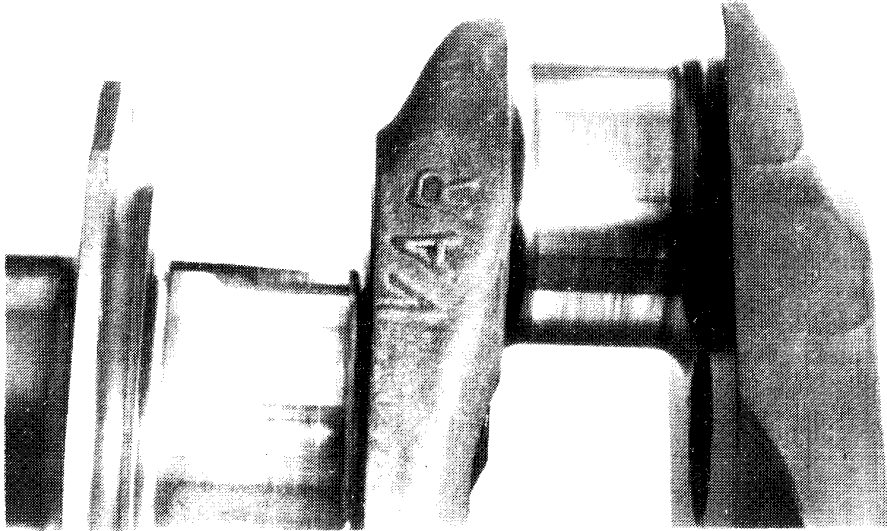
FIGURE 1

Crankshafts made from VAR process steel are identified with the raised letters VAR forged into the crankshaft. The VAR forging identification is on the number 3, 7 or 9 crankshaft cheek depending on the crankshaft part number. The VAR forging identification may have been partially removed during the balancing process. If the crankshaft is identified as VAR, vibroetch the crankshaft flange with the letter "V". This "V" should follow the serial number and heat code. Make an appropriate entry in the engine log book.

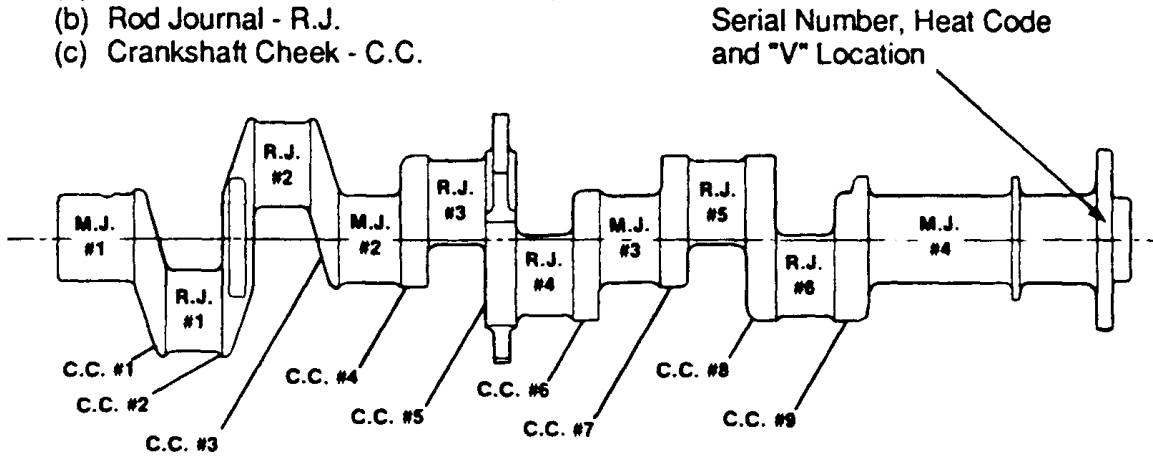
**FIGURE 3**

- (a) Main Journal - M.J.
- (b) Rod Journal - R.J.
- (c) Crankshaft Cheek - C.C.

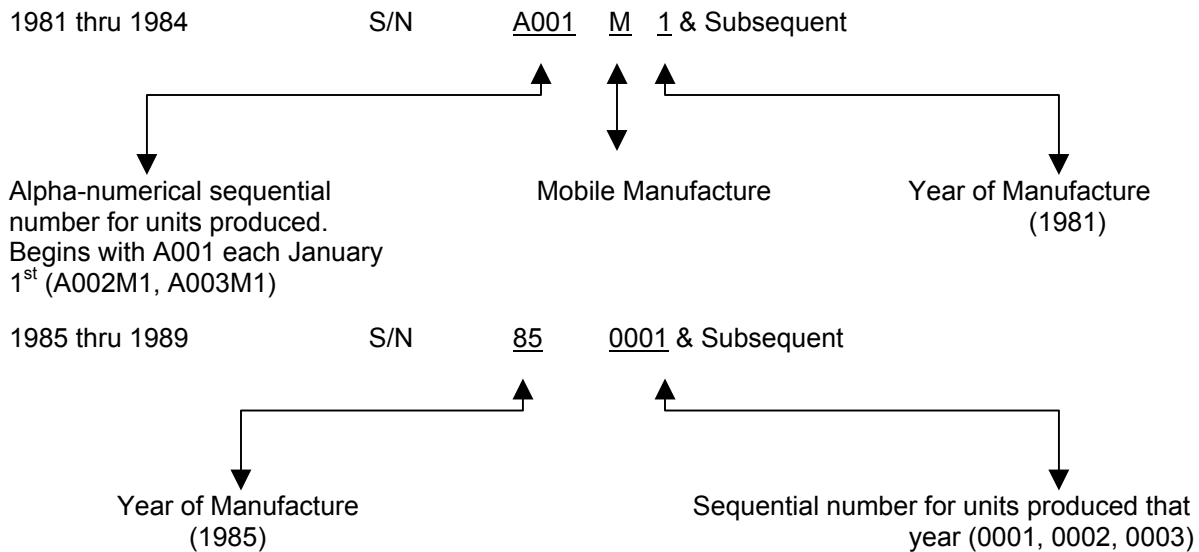
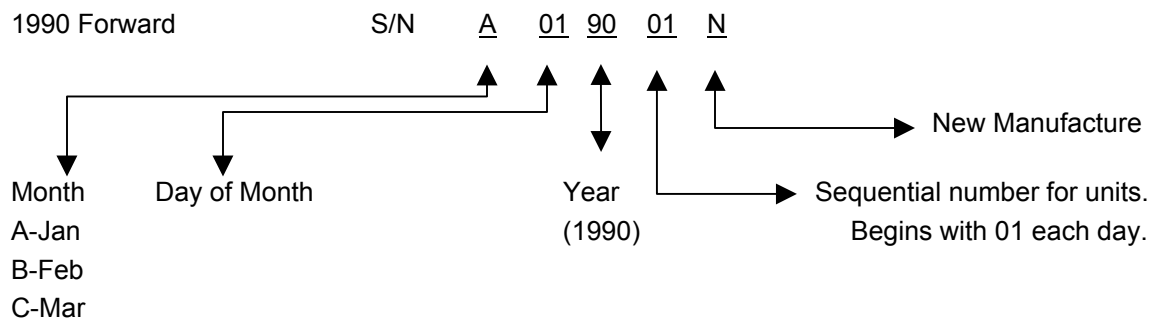
**SERIAL NUMBER INTERPRETATION**

All crankshafts with the following serial number sequences were manufactured using VAR steel and are not affected by this bulletin. The serial number is stamped into the flange of the crankshaft.

**IMPORTANT...**The absence of a serial number impression on the crankshaft flange indicates a non-VAR crankshaft and the crankshaft must be removed from service at engine overhaul or whenever the crankshaft is removed from the crankcase. If a serial number stamped on the flange is different than described below, the crankshaft must be examined at next overhaul or when removed or made accessible by crankcase disassembly to determine whether the VAR identification is present on the number 3, 7 or 9 cheek. If no serial number or VAR identification is present the crankshaft must be replaced.

- S/N A001M1 and subsequent. (1981 through 1984)
- S/N 850001 and subsequent. (1985 through 1989)
- S/N A019001N and subsequent. (1990 and subsequent)
