# service bulletin

M70-7  
FAA-DER Approved

**SUBJECT:** Increasing Size of Oil Feed Holes to Starter Adapter Shaftgear.

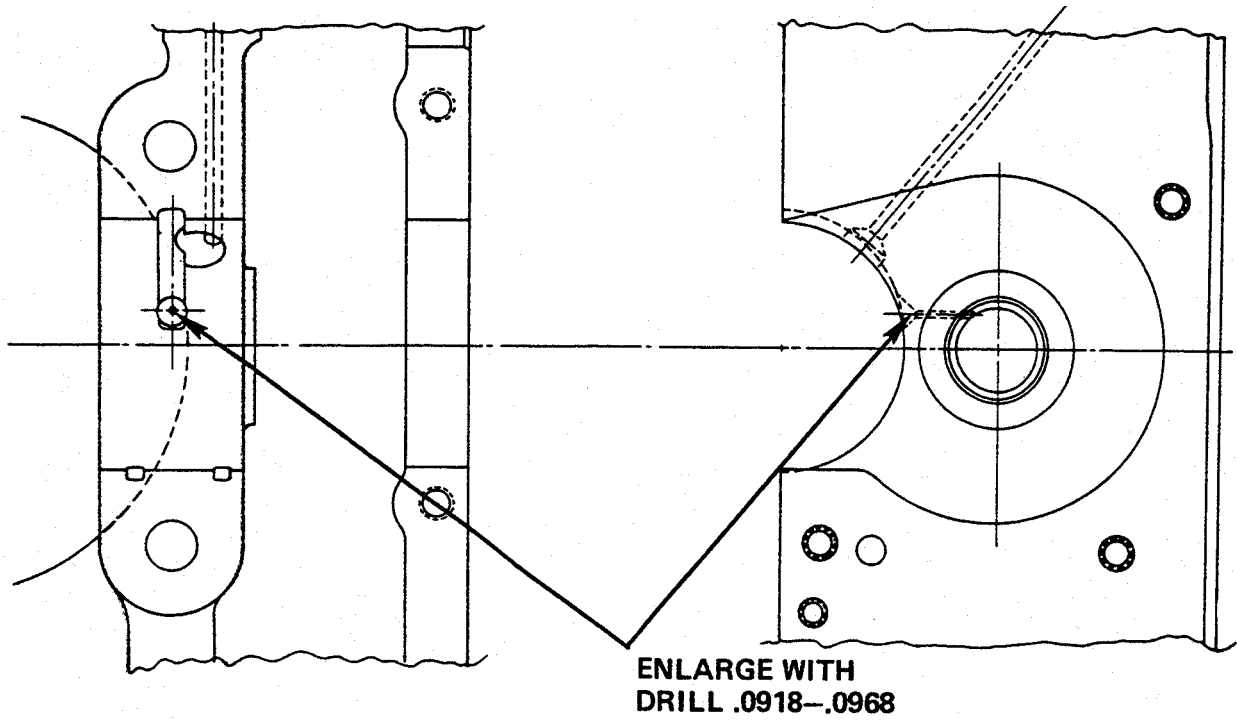
**SANDCAST CRANKCASE**

On engines with sand cast crankcases, the oil feed hole to the starter adapter shaftgear comes off the rear main bearing boss of the 1-3-5 crankcase half and enters the needle bearing counterbore near the top of the holes (at 10 to 11 o'clock position). This hole can be enlarged only at major overhaul or at any time the crankcase is disassembled. This should be accomplished per the illustration on page 2.

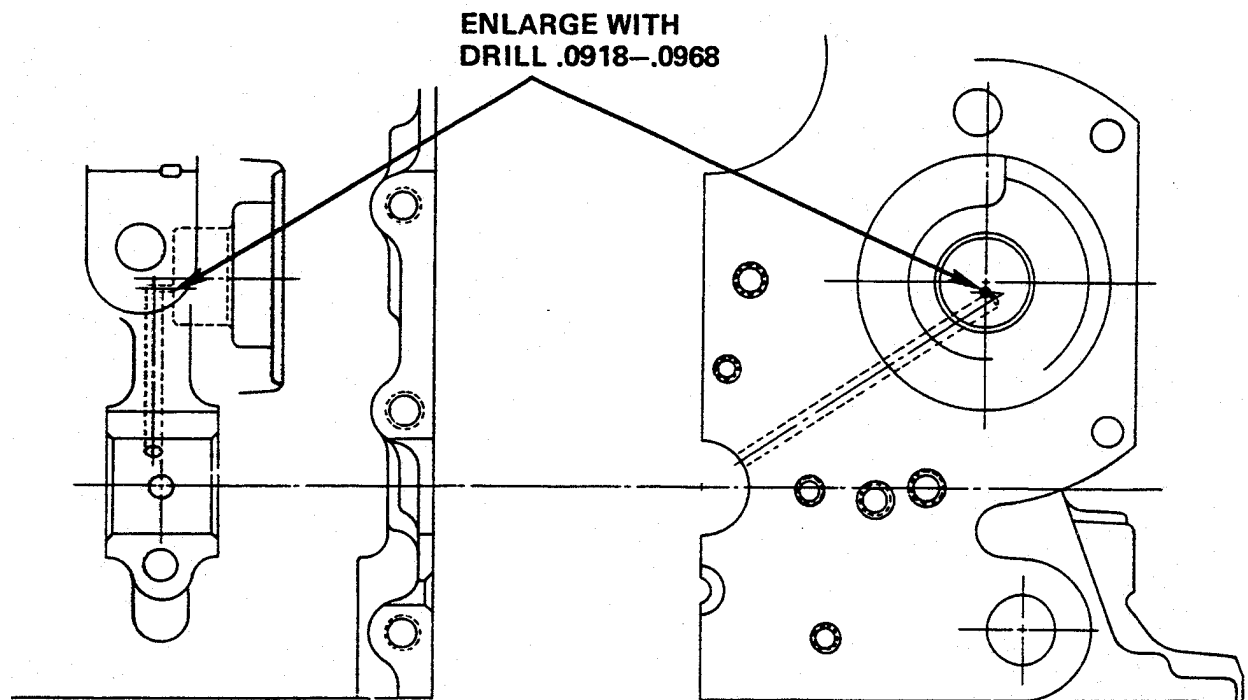
**PERMOLD CRANKCASE**

On Permold crankcases, the oil feed hole comes off the rear cam bearing of the 1-3-5 crankcase half and intersects a very short hole in the center of the needle bearing counterbore. This can be enlarged at any time with the starter adapter removed. Using a greased drill will help trap the chips. The oil system should then be pressurized to flow oil thru the enlarged hole before the starter adapter is replaced.
