# MANDATORY service bulletin

M87-24  
Supersedes M87-13

**SUBJECT: BROKEN STARTER ADAPTER SHAFTS**

**AFFECTED:** IO520BA, IO520BB, IO550B, TSIO520BE, TSIO520LB, TSIO520UB & TSIO520WB

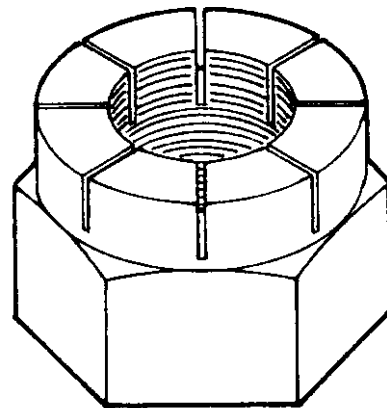
**FIGURE B**  
**STEEL LOCKING**  
**P/N 649311**

Some Teledyne Continental Motors' engines have continued to experience broken starter adapter shafts on aircraft that are equipped with air conditioning. (Ref. Mandatory Service bulletin M87-13).

- I. Gain access to the drive sheave mounted on the rear of the starter shaft. This sheave is concave and approximately 3.375 inch in diameter (3-3/8 inch).
- II. With a light and mirror, determine if the sheave is a steel locking type. (See Figure B.)
  - A. If the nut is a steel locking type (See Figure B), remove the freon compressor drive belt. This can most easily be accomplished by cutting the belt.
  - B. If the nut is castellated (See Figure A), ascertain via log books and maintenance records that the castellated nut is the original nut and has not been substituted for a steel locking type nut.
    1. If the castellated nut is the original, no further action is required. Make the appropriate log book entry stating compliance with this service bulletin and return the engine to service.

NOTE...REMOVAL/CUTTING OF THE BELT IS REQUIRED IF THE STEEL LOCKING TYPE NUT IS INSTALLED OR HAS PREVIOUSLY BEEN INSTALLED REGARDLESS OF THE SHAFT TYPE (COTTER KEY HOLE OR NO COTTER KEY HOLE).
