MANDATORY service bulletin

M87-25
Supersedes M86-17

15 December 1987

SUBJECT: **PISTON PIN REPLACEMENT AND THRU BOLT TORQUE CHECK**

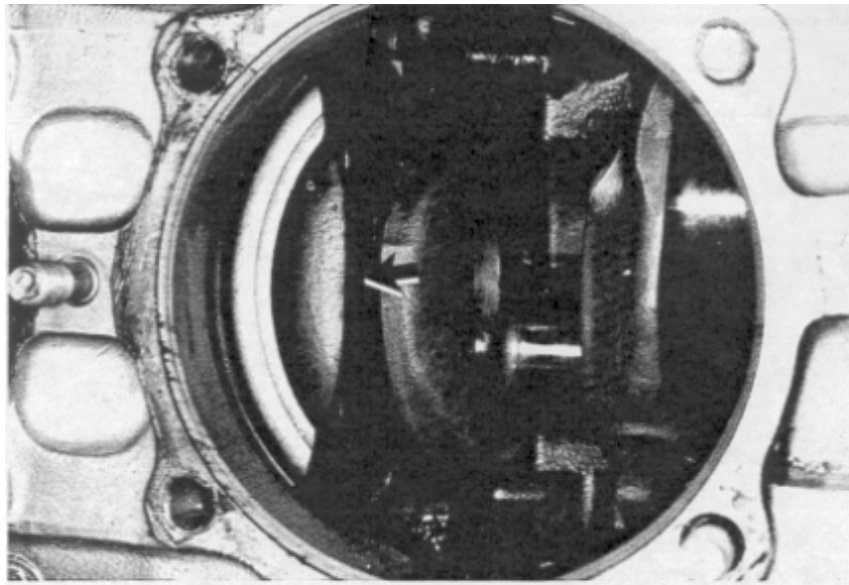
FIGURE A

Figure A depicts how bearing should generally appear.

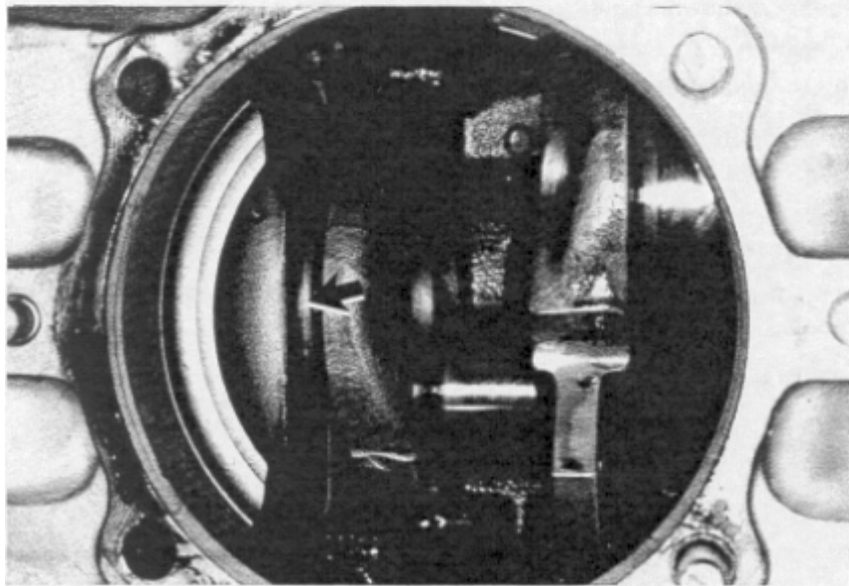
FIGURE B
(Continued)

Figure B depicts a bearing that has shifted.

NOTE...Contact your local Teledyne Continental Motors representative (See Page 4) for disposition of any bearing appearing as in Figure B or with any signs of crankcase material distress.
