service bulletin

M89-23
Technical Portions Are
FAA Approved

SUBJECT: **TSIO520CE LOWER THROTTLE BODY SUPPORT BRACKET AND
LINKAGE**

MODELS
AFFECTED: TSIO520CE

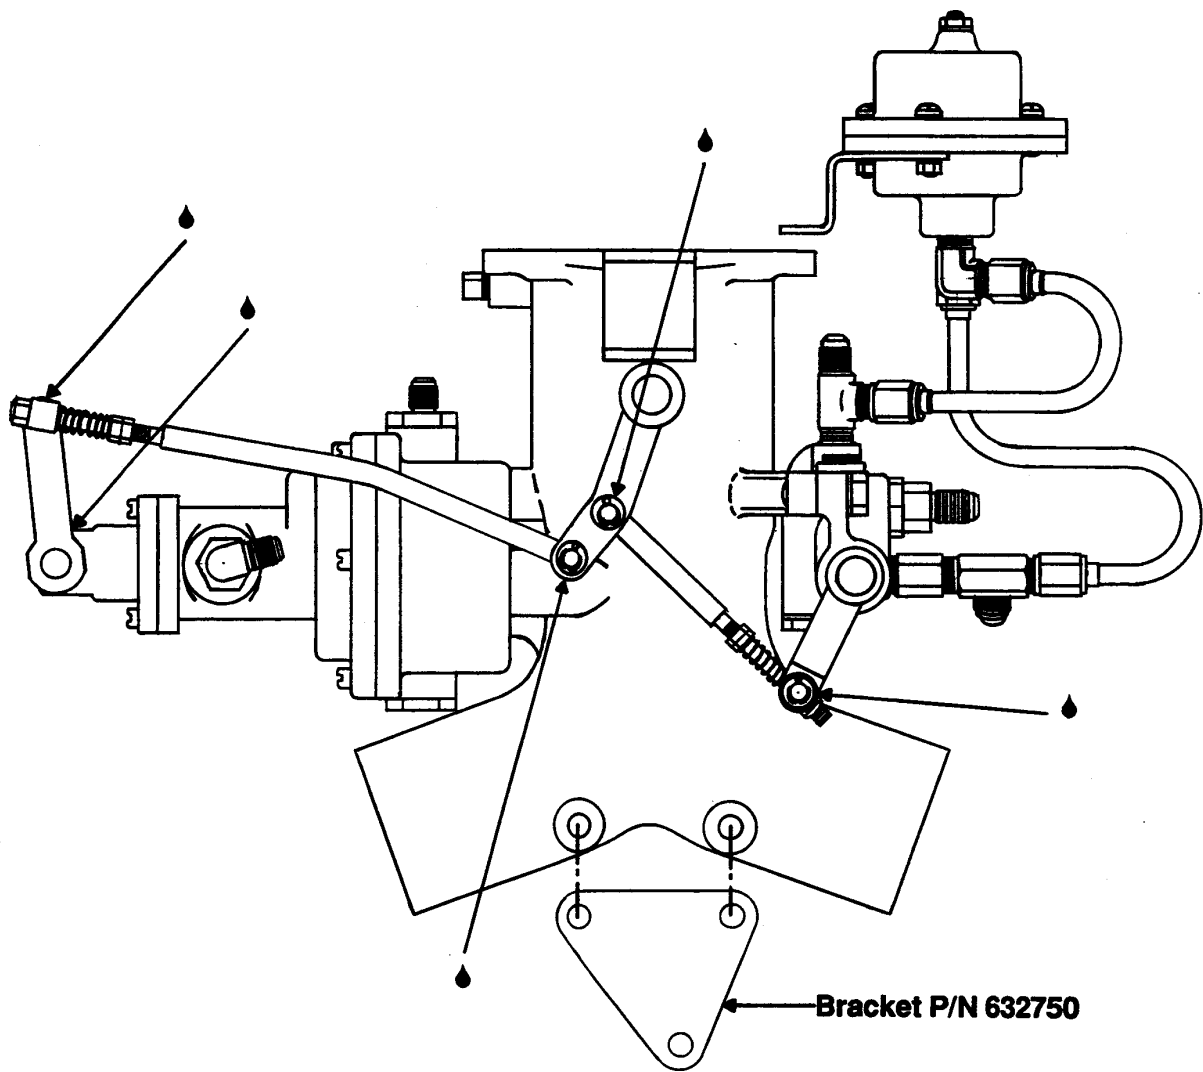
See illustration on page 2.

It has come to our attention through service tests conducted at Cessna Aircraft Corporation on the TSIO520CE engine that premature wear of the pin joints of the throttle and controller linkage has occurred. These pin joints should be inspected very carefully for wear and any necessary repairs be made.

In order to alleviate this premature wear, remove and discard the lower throttle body support bracket, P/N 632750.

Removal of this support bracket will reduce the vibration levels exerted on the controller and throttle linkage, and will in no way be detrimental to the operation of your engine.

NOTE...Lubrication of the linkage and controller cam must be accomplished at 100 hour inspections using clean 50 weight engine oil.
