TELEDYNE CONTINENTAL[®] AIRCRAFT ENGINE
MANDATORY SERVICE BULLETIN

Category 1
MSB08-2

SUBJECT: AD 2008-06-51 PRECISION AIRMOTIVE LLC[®] FUEL INJECTION SERVO

SUBJECT: HEX PLUG 383493 COMING LOOSE FROM REGULATOR COVER

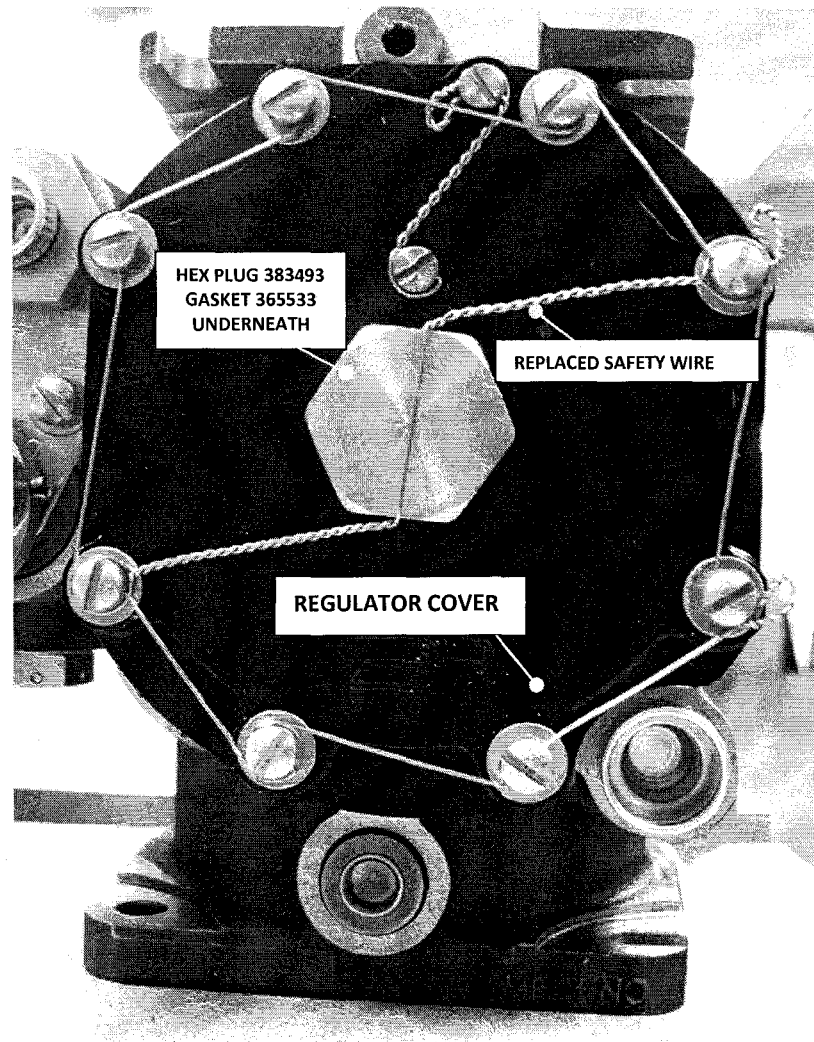
Precision Airmotive has recently learned of two incidents relating to its RSA fuel injection servos. In both cases the brass hex plug p/n 383493 on the cover of the regulator was found hanging from the safety wire, out of the hole, with damaged threads. In one instance the condition was found on the ground while troubleshooting a lean running condition. In the second instance the occurrence is believed to have happened in the air while flying at cruise power. The aircraft in the latter instance experienced a significant loss of power and misfiring while in flight. An off airport landing was made, resulting in considerable damage to the aircraft. The servos in these incidents had between 200 and 300 hours TSN. Precision Airmotive issued a Safety Alert on 3/3/08 requiring inspection of these plugs for looseness. Precision has now received additional reports of loose plugs on RSA-5 and RSA-10 servos on various different aircraft models. Precision Airmotive has determined that the gasket p/n 365533 located between the hex plug p/n 383493 and the servo regulator cover can shrink from engine heat which can cause the hex plug to lose torque against the regulator cover. The material in these gaskets was changed beginning August 22, 2006, and the gaskets that have been identified as experiencing shrinkage were all comprised of the new gasket material.

7. The hex plug must be safety wired with .025 inch diameter wire to the regulator cover as shown in the figure below. The wire shall pass thru the plug such that it pulls the plug in the tightened direction and does not touch the corners of the hex on the plug.

Note: Plug safety wire is wrapped around regulator screws under existing wire. It does not go through the holes in the screws.
