TELEDYNE CONTINENTAL[®] AIRCRAFT ENGINE
MANDATORY SERVICE BULLETIN

Category 1
MSB08-2B

SUBJECT: PRECISION AIRMOTIVE LLC[®] FUEL INJECTION
SERVO RSA-5, RSA-10

SUBJECT: HEX PLUG 383493 COMING LOOSE FROM REGULATOR COVER

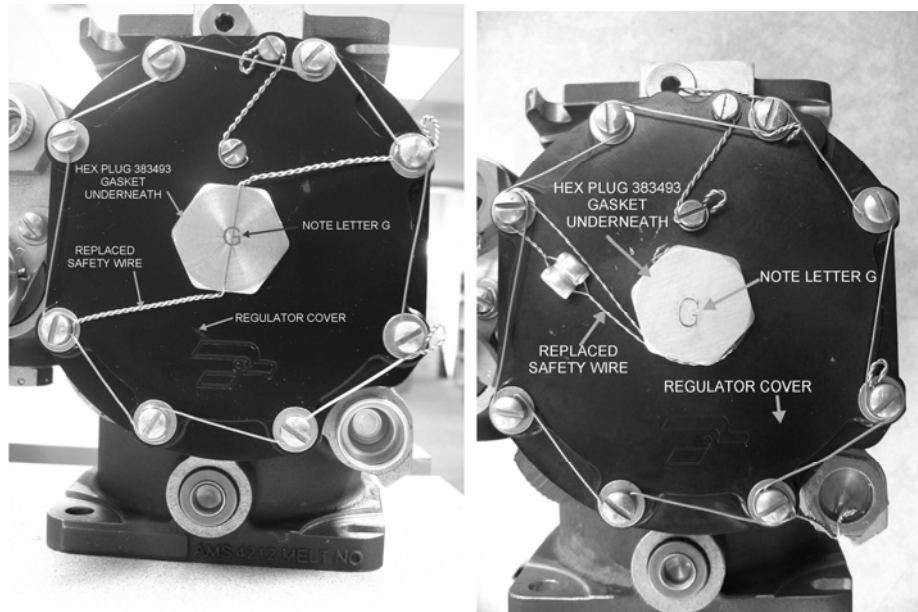
Note: The safety wire through the hex plug shown in the left hand photo is .025" wire wrapped around regulator screws under existing wire. It does not go through the holes in the screws. The safety wire through the hex plug shown in the right hand photo is .015" wire which passes through the regulator screw hole. This is the normal safety wire method used at the factory.

IMPORTANT: The letter "G" shown in the photos is to be stamped **ONLY** if the new gasket, part number 2577258 has been installed.

7. The hex plug must be safety wired with .015 thru .025 inch diameter wire to the regulator cover as shown in the photos on the next page. The wire shall pass thru the plug such that it pulls the plug in the tightened direction and does not rest on the corners of the hex on the plug (it is acceptable to wrap under the corners of the hex plug). These photos are just two examples of acceptable safety methods. Other safety wire methods such as those described in FAA AC 43-13-1B (or latest revision) are also acceptable.

6. Stamp or scribe the letter "G" onto the face of the hex plug as shown in the sample photos. This shall be done with the plug removed from the servo. **DO NOT** stamp the plug with it installed in the servo.
