TELEDYNE CONTINENTAL® AIRCRAFT ENGINE
MANDATORY SERVICE BULLETIN

Category 1
MSB09-1B
Supersedes MSB09-1, 1A
Technical Portions FAA
Approved

SUBJECT: CYLINDER REPLACEMENT

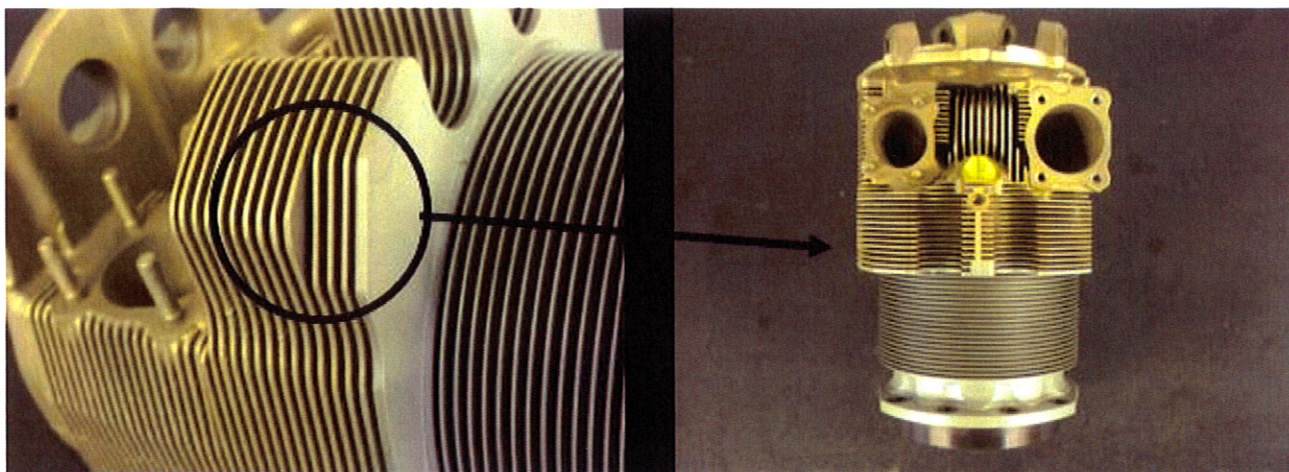
FIGURE 1
Cylinder Head Casting Four (4) Fin relief Location

The EQ3 head casting cylinder assemblies are identified by a four (4) fin relief at the bottom lower left hand portion of the cylinder head (as installed on the engine) and a depression cast EQ3 in the cylinder head rocker boss (overhead) area as shown in Figures 1 and 2. These cylinders are to be replaced in accordance with the guidelines set forth in this bulletin and based upon applicable engine model and aircraft manufacturer procedures. All EQ3 cylinders must be replaced no later than December 31, 2009.

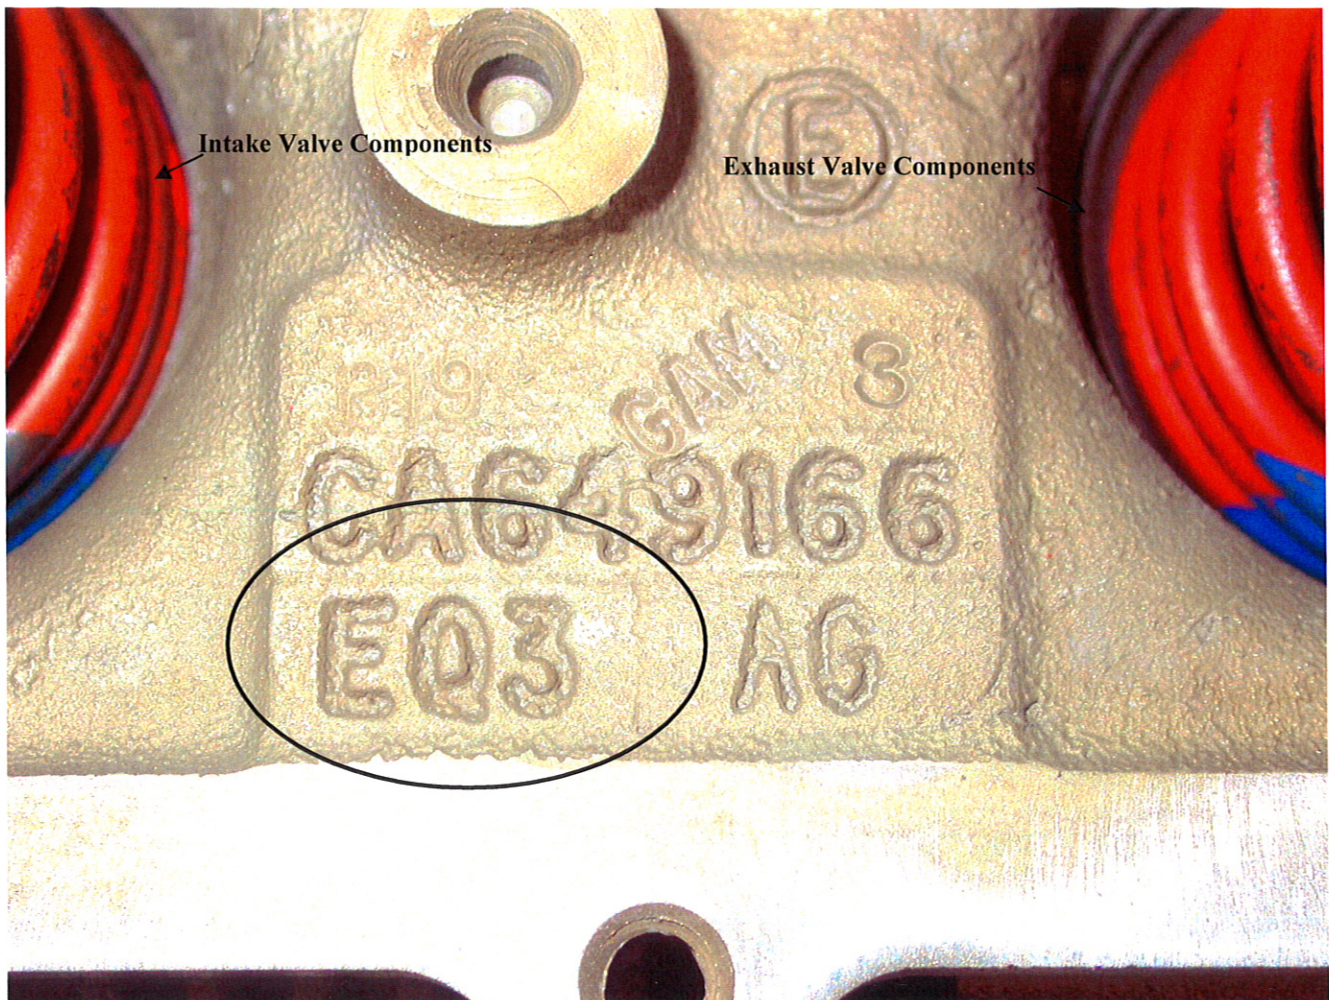
**FIGURE 2 Location of EQ3 Marking in the Cylinder Head Rocker Box
Overhead Area**

1. Cylinders with a depression cast EQ3 in the cylinder head rocker boss area as shown in Figure 2 are covered by this MSB and must be exchanged.
2. Contact TCM in accordance with the completion and registration section below.

"CAUTION": DO NOT INSTALL EQ3 CYLINDERS ON ANY ENGINE.

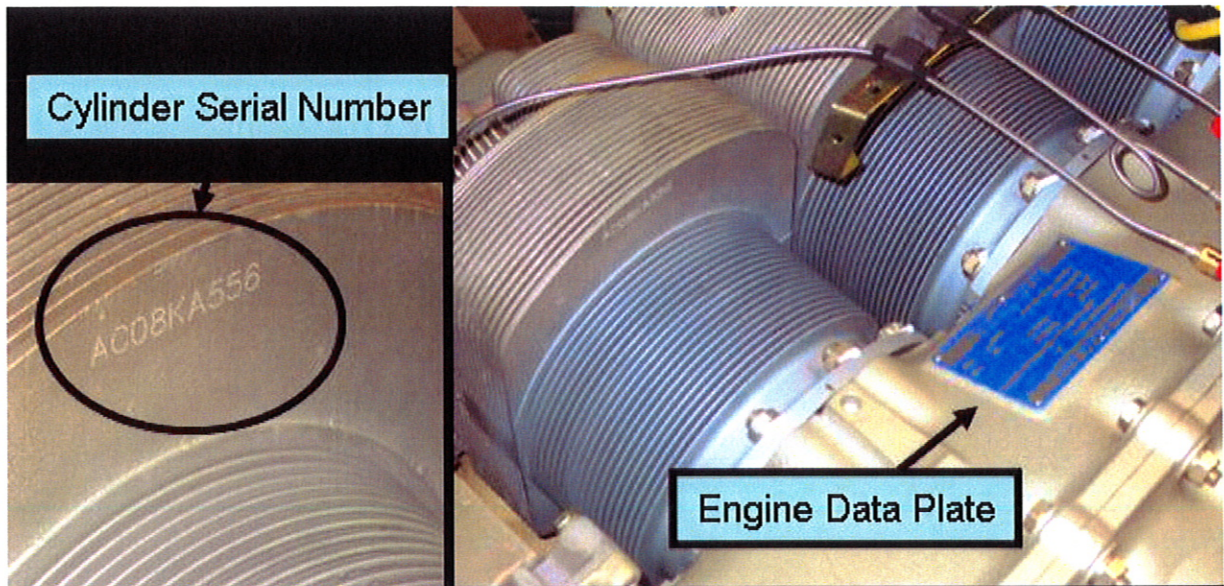
FIGURE 3
Cylinder Serial Number and Engine Data Plate Locations

- c. If a number casting mark **is not** present, then the cylinder may be covered by this MSB. Verify the EQ3 cylinder S/N as shown in Figure 3 is present and listed in Table 2. If so, proceed to completion and registration and **STEP 2**.

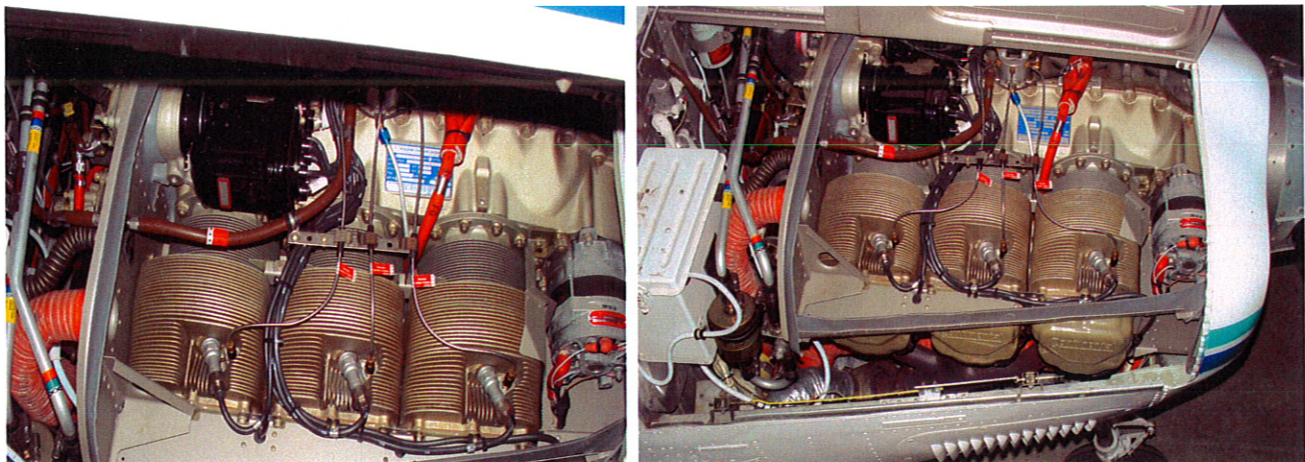
FIGURE 4
Example of Top Down View with Cowling Removed
Typical Engine Installation

1. Open or remove the engine cowl in accordance with the airframe manufacturer's instructions to the point necessary to allow visual access to the cylinders on both sides of the engine (Figure 4).

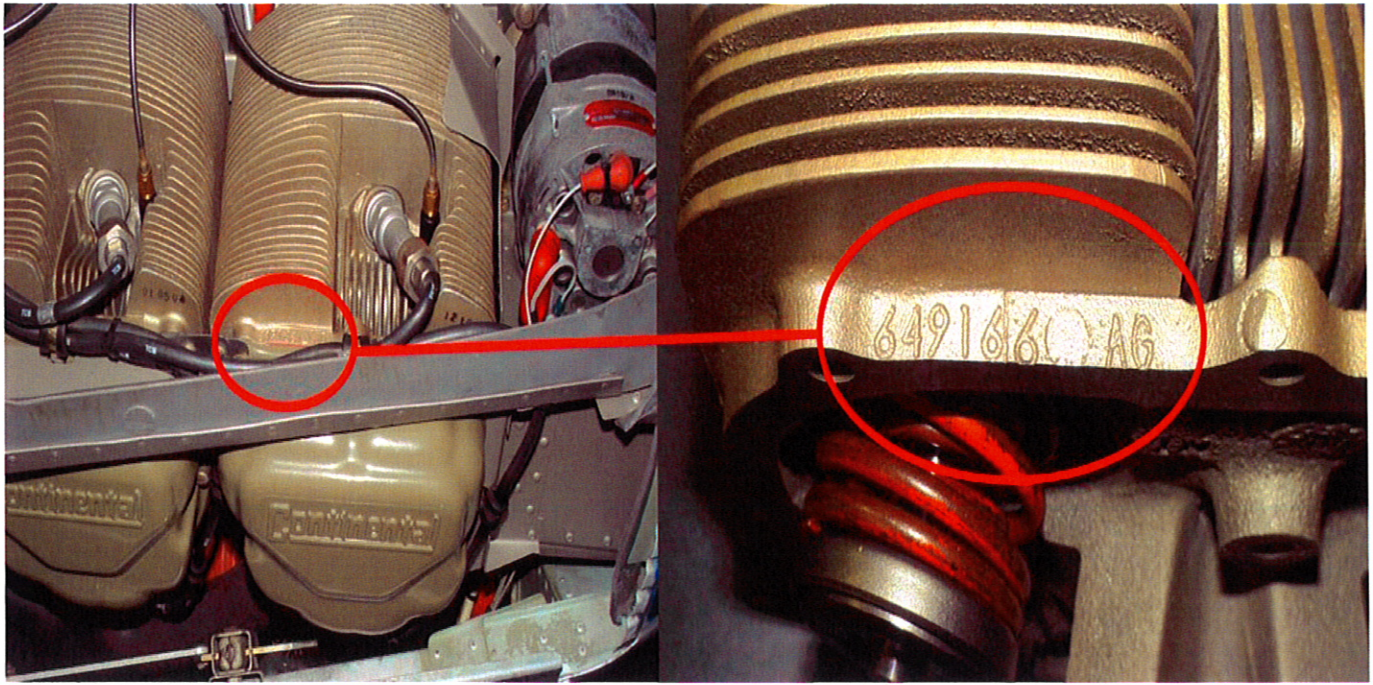
FIGURE 5

2. Access the area of the cylinder head casting as shown in Figure 5. This area is visible as you look down at the cylinders in their mounted condition from above the engine compartment.

- a. Look for a 6 digit part number casting mark such as "649166" or similar. In addition to the casting mark number, there may be a letter indicator such as AE, AD or similar. (Reference Figure 5)

- b. If a number casting mark is present, it indicates the cylinder head assembly is not covered by this MSB and no further action is required. . Make an engine logbook entry recording the results of this inspection and compliance with this MSB.

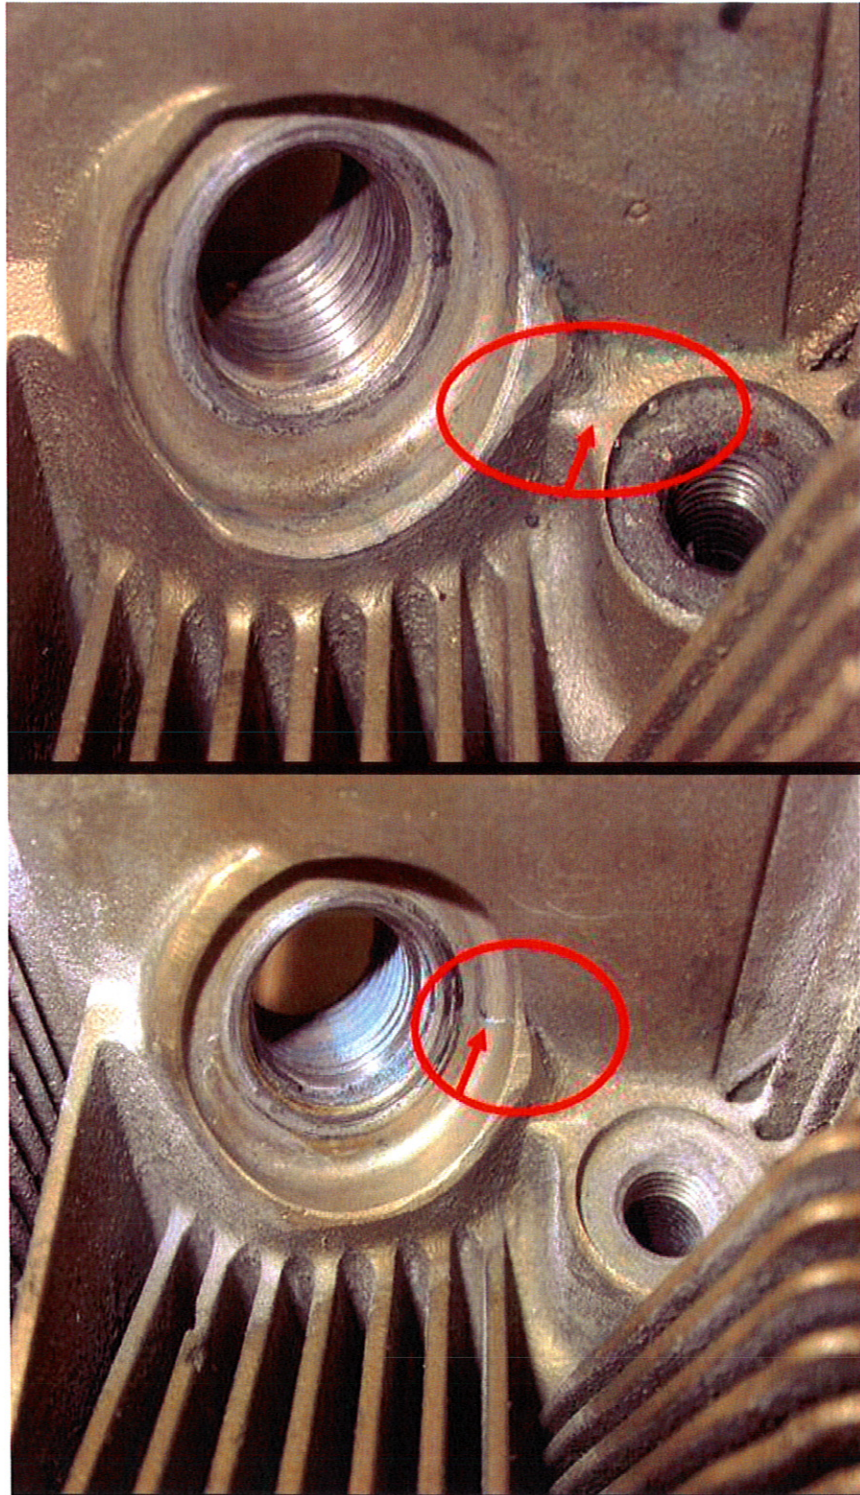
FIGURE 6
Typical Visual Crack Indications

NOTE: Visual evidence of a crack in the inspection area between upper spark plug bore and fuel injection nozzle/primer port as indicated in Figure 6 does not require further verification with a dye penetrant inspection.

IF A CRACK IS PRESENT, THE CYLINDER MUST BE REPLACED IMMEDIATELY. TO SUPPORT REPLACEMENT AT AN AUTHORIZED MAINTENANCE FACILITY, AN FAA SPECIAL FLIGHT PERMIT FOR A REPOSITIONING FLIGHT MUST BE REQUESTED FROM THE LOCAL FAA. THIS FLIGHT MAY BE AUTHORIZED ONLY IF NO FUEL OR COMBUSTION STAINING IS FOUND AT THE SUBJECT INSPECTION LOCATION. IF STAINING IS FOUND, DO NOT OPERATE THE ENGINE AND CONTACT TCM FOR ASSISTANCE PRIOR TO FURTHER FLIGHT

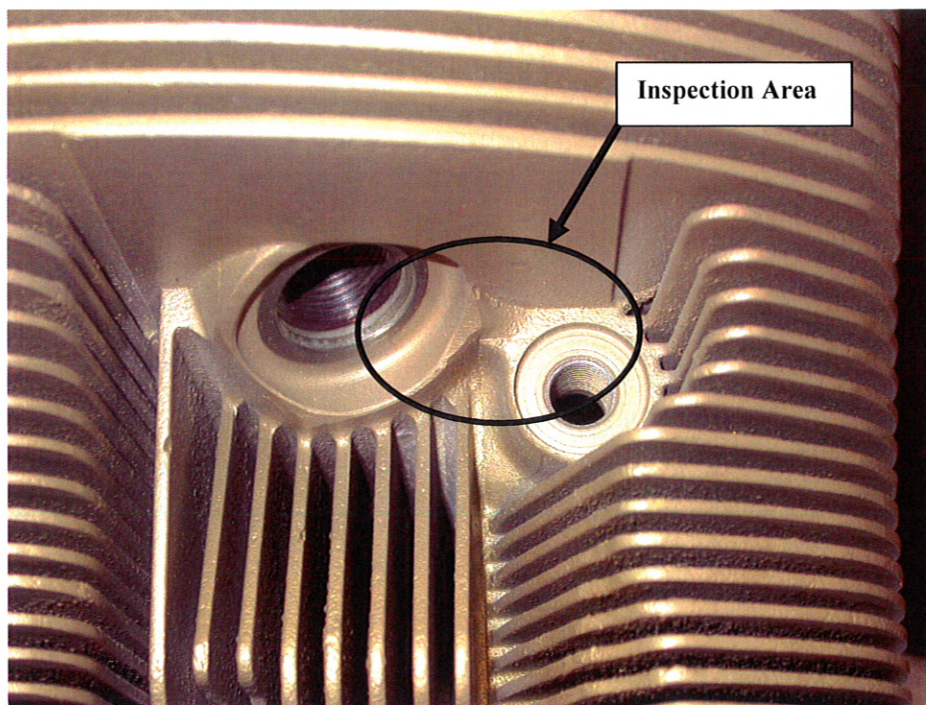
FIGURE 7
Inspection Area Between Upper Spark Plug Bore and Fuel Injection
Nozzle/Primer Port

7. Using Dye-penetrant "Cleaner/Remover", thoroughly clean the area between the upper spark plug bore and fuel injection nozzle/primer port as shown in Figure 7.
8. Spray the "Penetrant/Dye" onto the clean/dry area indicated in Figure 7. Allow the "Penetrant/Dye" enough time to set in accordance with the manufacturer's instructions.
9. Remove and clean the area in which the "Penetrant/Dye" was applied in accordance with the manufacturer's instructions.

10. Spray the “Developer” onto the clean/dry area indicated in Figure 7. Allow the “Developer” enough time to dwell in accordance with the manufacturer’s instructions for the determination of the existence of a crack.

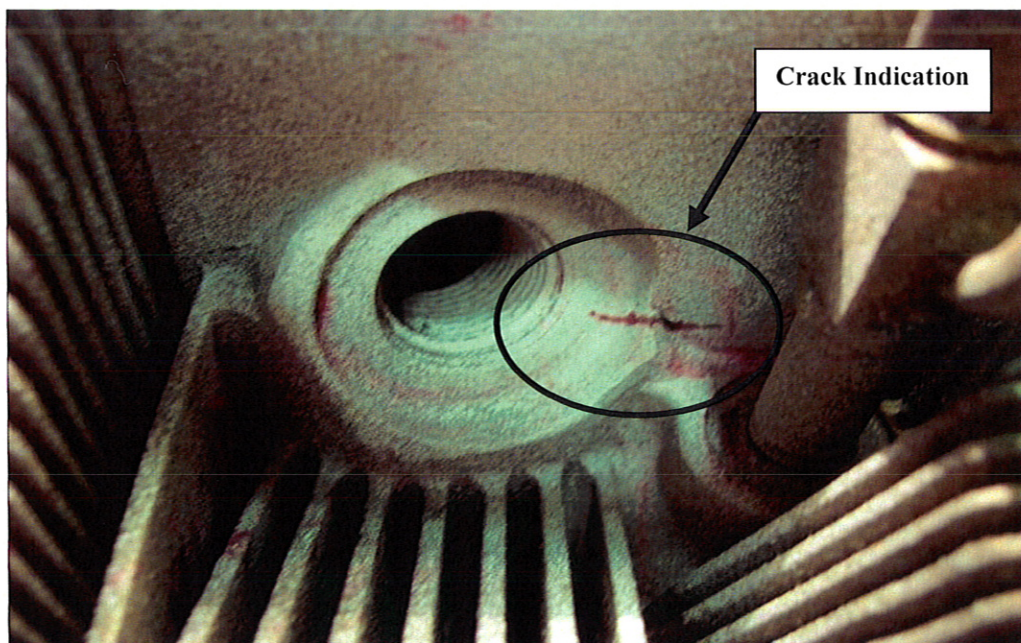
FIGURE 8 **Cylinder Head Crack Indication with Dye Penetrant**

- a. If a crack is present, its appearance and location will be similar to that shown in Figure 8.
 - b. Refer to Step 12, below, for required actions in either a “No Crack Present” or a “Crack Present” case.

- b. Preceding Inspection Reveals Cracks
 - i. If a crack is verified and fuel or combustion staining was noted in the inspection area, contact TCM before further flight.

- ii. Contact TCM via one of the means listed below and on the Customer Information Form to schedule replacement of the affected cylinder(s).
 - iii. If a crack is verified see the following warning for contact instruction.

IF A CRACK IS PRESENT, THE CYLINDER MUST BE REPLACED IMMEDIATELY. TO SUPPORT REPLACEMENT AT AN AUTHORIZED MAINTENANCE FACILITY, AN FAA SPECIAL FLIGHT PERMIT FOR A REPOSITIONING FLIGHT MUST BE REQUESTED FROM THE LOCAL FAA. THIS FLIGHT MAY BE AUTHORIZED ONLY IF NO FUEL OR COMBUSTION STAINING IS FOUND AT THE SUBJECT INSPECTION LOCATION. IF STAINING IS FOUND, DO NOT OPERATE THE ENGINE AND CONTACT TCM FOR ASSISTANCE PRIOR TO FURTHER FLIGHT
