TELEDYNE CONTINENTAL[®] AIRCRAFT ENGINE

SERVICE BULLETIN

SB01-5

SUBJECT: STARTER ADAPTER BEVEL GEAR INSPECTION

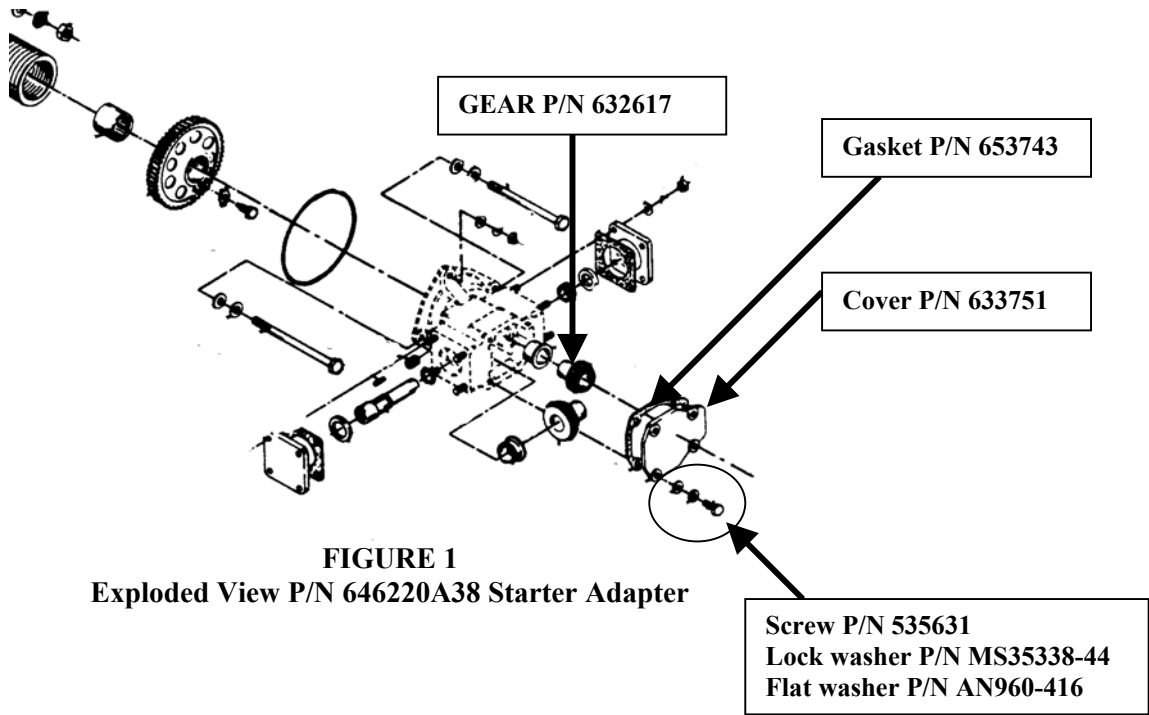
FIGURE 1
Exploded View P/N 646220A38 Starter Adapter

For affected engines listed in Table 1 and engines with field repaired or overhauled starter adapter P/N 646220A38 that utilized bevel gear P/N 632617; within the next 25 hours of engine operation perform a visual inspection of bevel gear P/N 632617 for spalling as outline below. Repeat this inspection at 50 hour intervals until starter adapter P/N 646220A38 is replaced with current production starter adapter P/N 646220A54.

1. In accordance with the aircraft manufacturer's instruction gain access to the engine and specifically the engine accessory area.
2. Referring to Figure 1, remove the "T" drive cover plate P/N 633751, by removing 4 each screws, 4 each lock washers and 4 each flat washers. Remove gasket P/N 653743.
3. Visually inspect bevel gear P/N 632617 for indication of gear tooth distress, spalling, broken or chipped gear teeth. Inspect interior of "T" drive housing for gear debris.
4. If visual inspection DOES NOT reveal any damage to bevel gear P/N 632617 and there is no gear debris noted in "T" drive housing interior reinstall cover P/N 633751 using a new gasket P/N 653743 and new lock washers P/N MS35338-44. Torque screws P/N 535631 to 75 to 85 inch pounds.
On completion of the above inspection, complete the owner notification form and mail it or fax it to TCM. ①

5. If visual inspection reveals damage to bevel gear P/N 632617 or if there is debris in the interior of the "T" drive housing the starter adapter assembly will have to be removed for repair or replacement. Contact TCM Technical Service Support at 1-888-826-5465
