**TELEDYNE CONTINENTAL ® AIRCRAFT ENGINE**

**SB05-11**

**SUBJECT: PIPER SERVICE BULLETIN 1157A**

**SUBJECT:** FIELD UPGRADE OF PRESSURIZED MAGNETOS & TACHOMETER SENSOR ASSEMBLIES

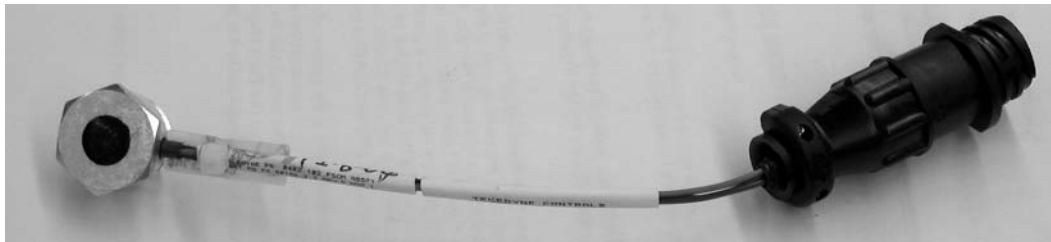
Figure 1  
Magneto Sensor Assembly

Field service reports for these installations indicate that the magneto pressurization systems installed on the magnetos listed in MODELS AFFECTED may be capable of depositing moisture inside the magnetos when part number 598-881 tachometer sensor is installed on the magneto.

6. Check the tachometer sensor assembly for correct part number on the sensor cable, PS 50158-2-2 Rev D Mod 1. See Figures 1 and 2 for identification.
7. Replace the tachometer sensor if the tag does not have Rev D Mod 1 as illustrated in Figure 2.

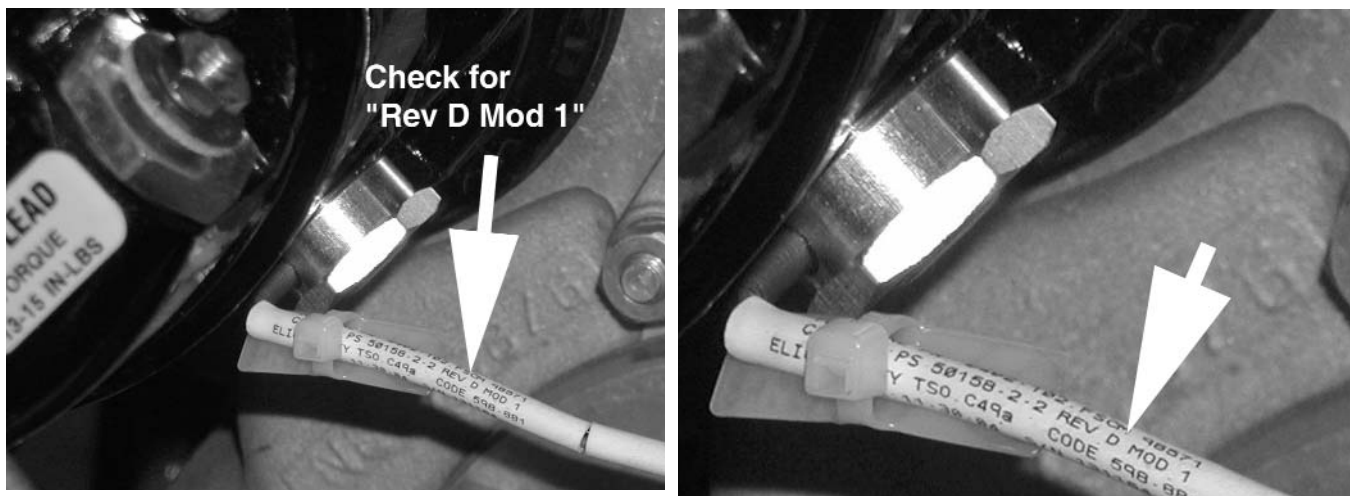
Figure 2  
Correct Sensor Identification

Two improvements to the sensors, which have eliminated the inadequate air supply flow, are: (1) an increased bleed port from .015 inches to .025 inches; and, (2) removing the filter element from the bleed port. To distinguish between the old and the modified Hall Effect Magneto Sensor Assemblies, Teledyne has identified the new sensor part number as 0402-102 Mod 1.

9. On all affected aircraft if the tachometer sensor is not labeled PS 50158-2-2 Rev D Mod 1 that tachometer sensor must be replaced with a 598-881 labeled PS 50158-2-2 Rev D Mod 1. Tachometer sensors that require replacement will be replaced free of charge per the limitations of the SUMMARY section of this bulletin.
