TELEDYNE CONTINENTAL ® AIRCRAFT ENGINE

SB05-9

SUBJECT: SLICK SERVICE BULLETIN SB1-88B

SUBJECT: Periodic Inspection of Slick Models 6320, 6324, 6360, 6361, 6363, and 6365 Pressurized Magnetos

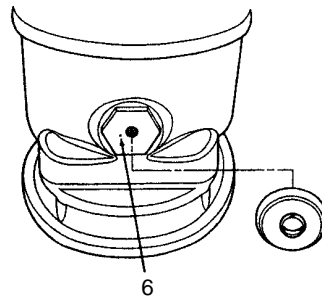
Figure 9

- (12) Harness Cap "O" Ring (not shown in Figure 2) - Check "O" ring M3184 for wear and replace as necessary.
- (13) Orifice Vent (6) - Check and clean orifice vent M3179 to insure it is clean and free of obstruction. Reference paragraph 3.B of this bulletin. Maximum orifice diameter is .025 inch. See Figure 9.

NOTE: Moisture contamination is more likely to occur on magnetos that have Piper PN 84652-002, Teledyne Controls PN 0402-102 tachometer sensor installed on the magneto in place of the factory orifice vent. Tachometer sensors identified as Mod 1 do not have this problem.

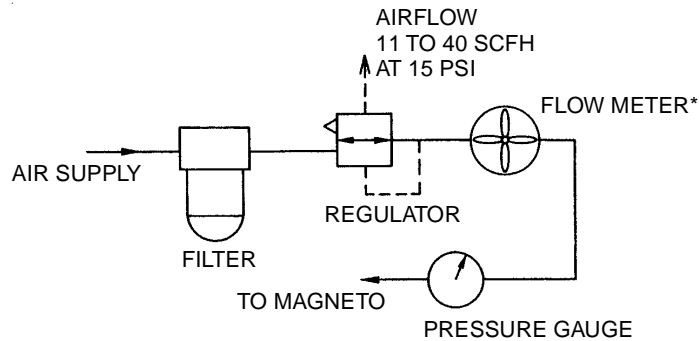
- B. Pressure Testing - After magneto reassembly, install a pressurized harness cap and apply 15 PSI filtered air to the inlet nozzle of the magneto. Air flow at 15 PSI should be 11 to 40 standard cubic feet per hour (SCFH). If flow is excessive, reposition gaskets and re-torque housing and harness cap screws. Screws should be torqued to 18-20 in.-lbs. See Figure 12 for Test Apparatus details. Testing should be conducted with magneto at room temperature.

NOTE: Airflow limits apply only to the magneto, and do not include any other engine accessories or plumbing. If the airflow is less than 11 SCFH, replace the tachometer sensor with either Piper PN 84652-002 Mod 1 or Teledyne Controls PN 0402-102 Mod 1.
