SERVICE BULLETIN

SB08-1

SUBJECT: ROCKER SHAFT INSPECTION AND REPLACEMENT

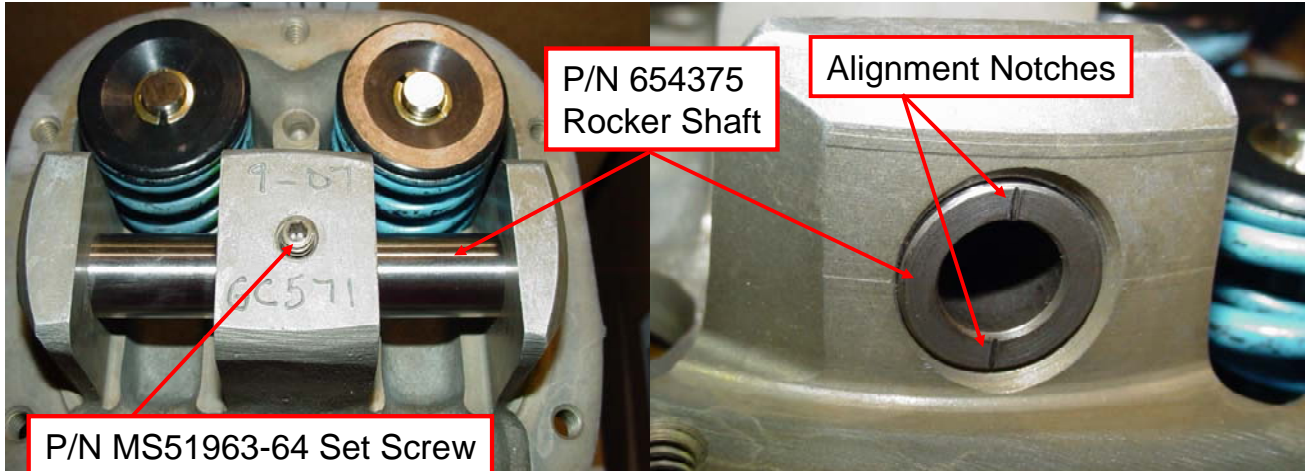
All engines listed above, manufactured after November, 1997 and those which have had cylinders replaced after November, 1997 may utilize the P/N 654375 Rocker Shaft and the P/N MS51963-64 retaining screw. Teledyne Continental Motors (TCM) has received reports from the field of some P/N MS51963-64 Rocker Shaft Retaining Screws losing torque, allowing the P/N 654375 Rocker Shaft to chafe the rocker cover.

FIGURE 1
P/N 654375 ROCKER SHAFT INSTALLATION
(ROCKER ARMS REMOVED FOR CLARITY)

- 4) If the P/N 654375 Rocker Shaft is installed proceed as follows:
 - a) Rotate the engine to bring the piston to top dead center. Both valves will be closed.
 - b) Remove and discard the P/N MS51963-64 Rocker Shaft Retaining screw.
 - c) Remove the P/N 654375 Rocker Shaft and retain for return to TCM.
 - d) Reinstall the rocker arms utilizing a new P/N 21153 Rocker Shaft.
