TELEDYNE CONTINENTAL ® AIRCRAFT ENGINE  
**SERVICE BULLETIN**

Category 3  
**SB09-4A**

**SUBJECT:** Crankcase inspection for “Permold” engines equipped with Air Conditioner systems installed from 1998 to present.

**PURPOSE:** To issue instructions for a required crankcase inspection at the forward Air Conditioner bracket attachment boss

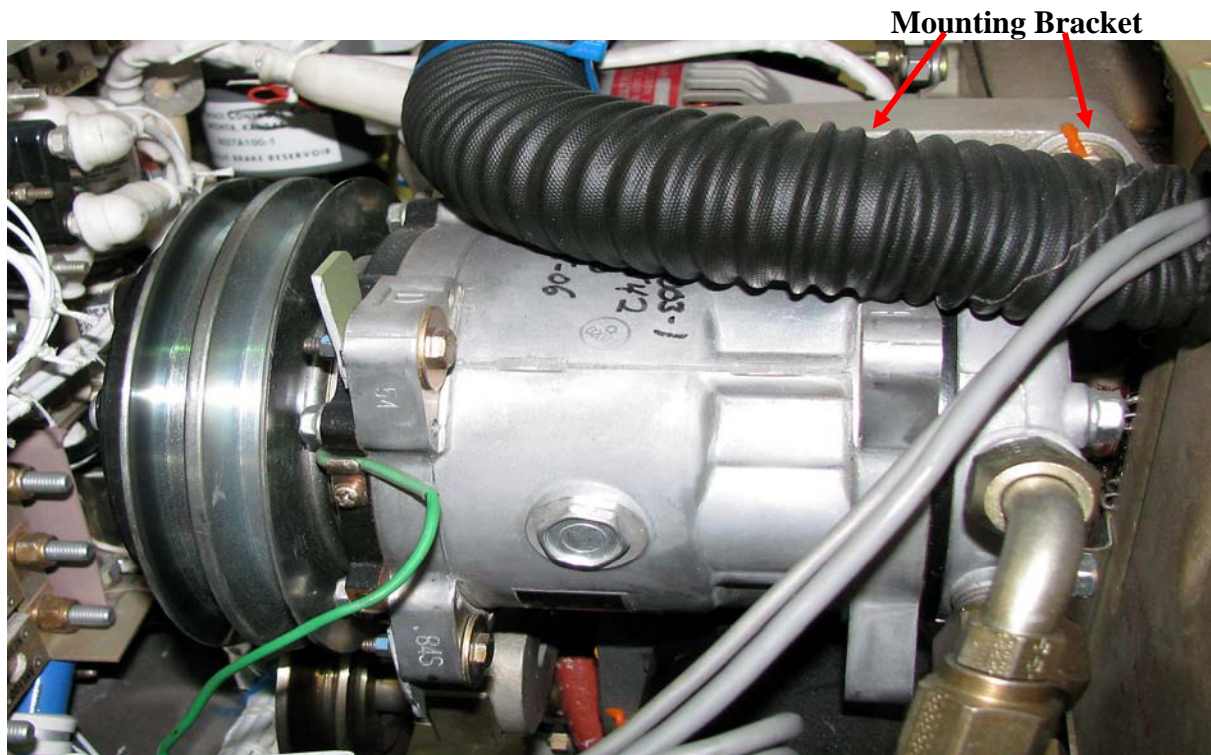
**FIGURE 1**  
Compressor installation

The TCM supplied brackets are part of an EQ (equipment) kit that includes all parts to enable installation of an air conditioning compressor system by aircraft OEMs and other installers. See Figure 1 for a typical installation on an IO550B model engine.

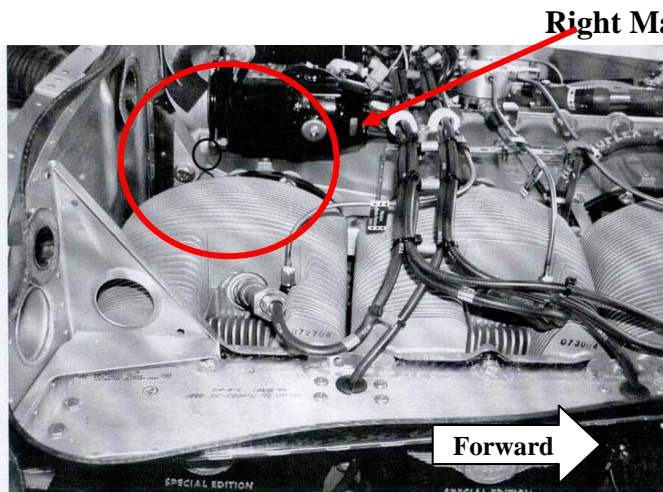
**FIGURE 2**  
General Area

- Inspect the rib at the front air conditioner bracket attach point of bracket up to the Right Magneto flange attachment opening and magneto lower attachment clamp ( See Figures 2,3)

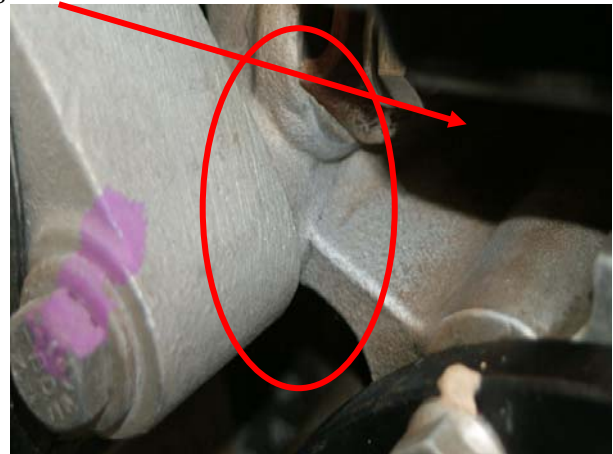
**FIGURE 3**  
Compressor bracket  
attachment bolt boss crack  
indication

TCM has confirmed reports of cracks in a rib of some Permold crankcases that are equipped with TCM supplied air conditioning compressor brackets. The rib extends from the 11:00 o’clock position of the number 1 cylinder to the forward air conditioner compressor bracket attachment boss. (See Figures 5 and 6) There are two crankcase rib configurations, a “thinner rib” and a “thicker rib”. These two rib configurations are shown in Figures 5 and 6. The cracks occur in the “thinner rib” crankcases near the forward air conditioner compressor bracket attach bolt point. Figure 3 exhibits a crack indication in a “thinner rib” crankcase. This service bulletin requires inspection of the “thinner rib” configuration for cracks and replacement of the air conditioning compressor bracket on all “thinner rib” crankcases.

- If a crack is present, its appearance and location will be similar to that shown in Figure 3 and Figure 7. See following criteria for cracks to determine what specific further action is required

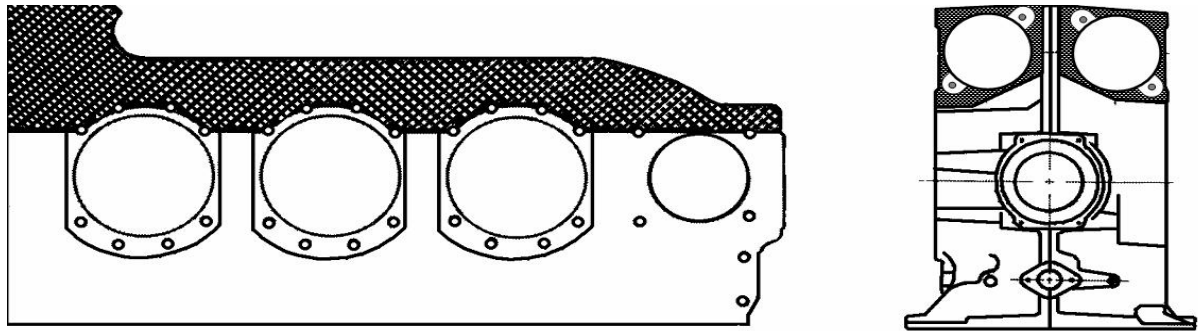
**FIGURE 4** Crankcase 1-3-5 half  
 Critical area depicted in white  
 Non-critical area depicted in shaded area

The cracks in the thinner rib are in the “Non-critical” area of the crankcase as identified in Figure 4 of this bulletin and prior in Service Bulletin M90-17. Figure 4 shows an illustration of the areas designated as critical and non-critical.

**Critical (white) and Non-critical (shaded) areas are illustrated in Figure 4.**

If a crack is observed in the non-critical (shaded) areas **less than two (2) inches in length**, it should be re-inspected for crack progression and signs of oil leakage at the next 50 hours of operation.

If a crack is observed in any of the non-critical (shaded) areas **more than two (2) inches in length** or if a previously observed crack has progressed to two (2) or more inches in length, remove the engine and repair or replace the crankcase or prior to further flight.

If any crack is observed in a critical (white) area, remove the engine and repair or replace the crankcase or prior to further flight.

If no crack progression is observed and no additional cracks are evident, continue to re-inspect at regular intervals not to exceed 100 hours duration or at Annual inspection.

- A. Any crack in the critical (White) area.
- B. Any crack two (2) inches or more in length in the non-critical (shaded) area.
- C. Any size crack that is leaking oil (not seeping).

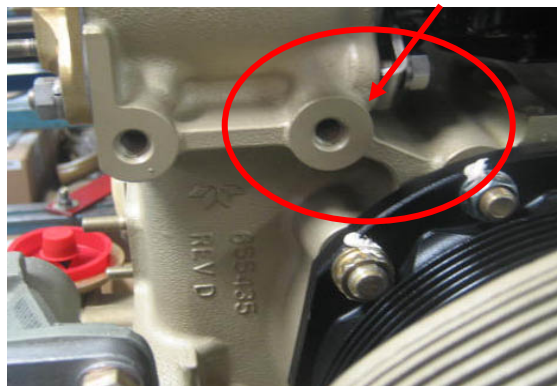
**FIGURE 5**  
 Thinner Rib  
 (Approximate thickness 3/8")

**All “thinner rib” crankcases, as pictured in Figure 5 MUST BE INSPECTED.**

- Utilizing an adequate light source and 10X magnification device, visually inspect the outside of the forward A/C bracket attach point boss as shown in Figure 5

Recurring inspection is required each 50 hours of operation until the air conditioner bracket is replaced with the superseding bracket as listed on Page 6. Replacement with the superseding air conditioner bracket will remove the inspection requirements of this Service Bulletin.

TCM has superseded the Air Conditioner bracket for all affected engine models. All brackets installed on “Thinner Rib” crankcases must be replaced with the superseding number.

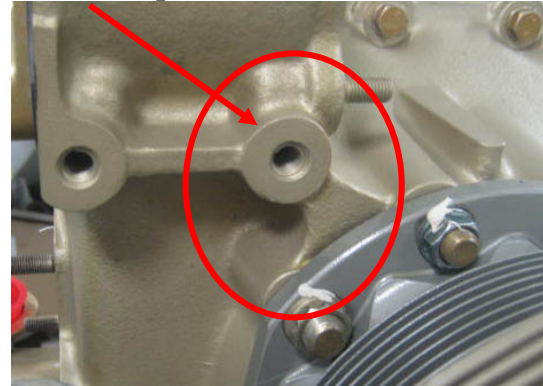
**FIGURE 6**  
 Thicker Rib  
 (Approximate thickness 3/4")

**“Thicker rib” crankcases as pictured in Figure 6 require NO INSPECTION**

No inspection is required on the thicker rib crankcases. Make a log book entry that this Service Bulletin is Not Applicable by crankcase rib thickness. No further action is required on these “thicker rib” crankcase engines.

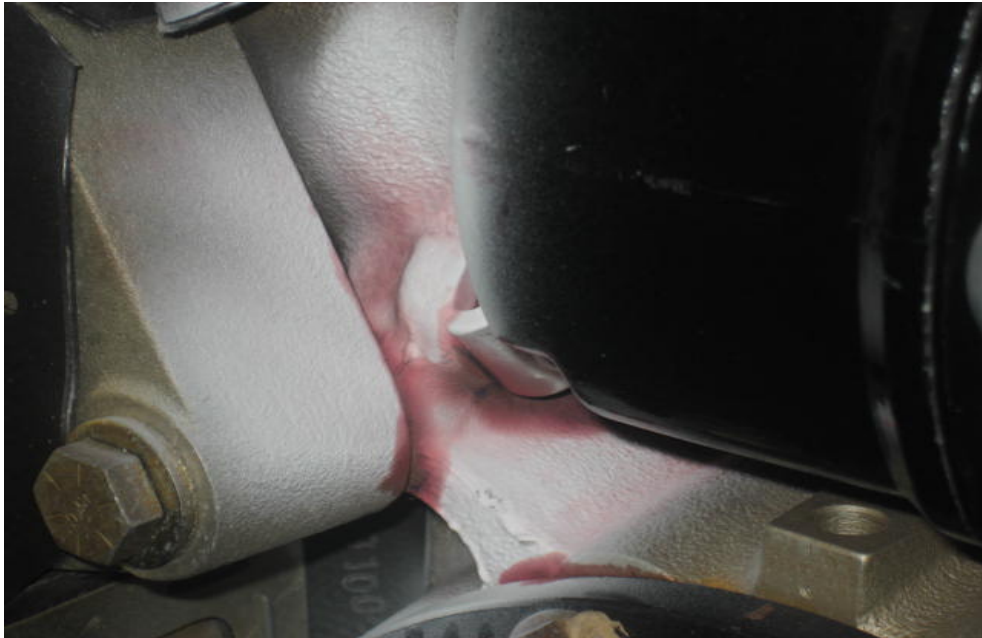
**FIGURE 7**

Example of Dye-penetrant inspection area

- Spray the “Penetrant/Dye” onto the clean/dry area as illustrated in Figure 7. Allow the “Penetrant/Dye” enough time to set in accordance with the manufacturer’s instructions.

- Remove the excess “Penetrant Dye” and clean the area where the “Penetrant/Dye” was applied in accordance with the manufacturer’s instructions.
- Spray the “Developer” onto the clean/dry area as illustrated in Figure 7. Allow the “Developer” enough time to dwell for the determination of the existence of a crack, in accordance with the manufacturer’s instructions.
