SERVICE BULLETIN

SB94-7

SUBJECT: CHRANKSHAFT FLANGE TIMING MARKS

PURPOSE: TCM Quality Assurance has identified a small number of crankshafts that were marked with incorrect timing marks that must be removed to prevent magneto timing from being set with reference to these marks.

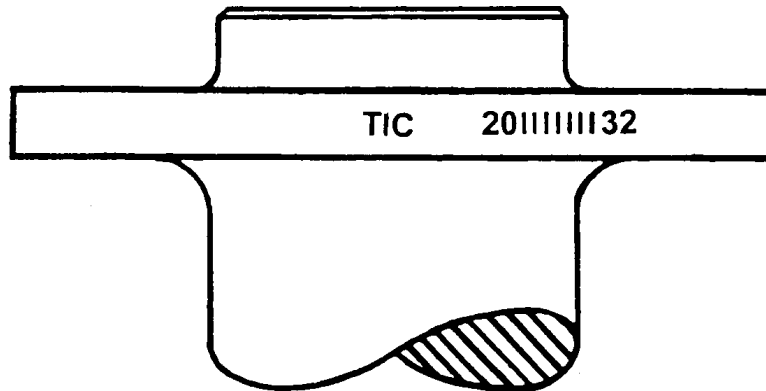
**CORRECT CRANKSHAFT FLANGE TIMING MARKS
FIGURE 1**

1. Remove the propeller and associated parts to gain access to the crankshaft flange timing marks.
2. Correct crankshaft flange timing marks are illustrated in Figure 1. If the crankshaft is marked correctly, verify magneto timing and make a log book entry as to compliance with this service bulletin.
3. If incorrect crankshaft flange timing marks are found as illustrated in Figure 2, proceed as follows.
4. Remove degree numbers and marks by buffing with 180 grit emery cloth. Do not remove the TC mark. Maximum depth of buffing is .002 inch. Buffed area must be smooth with no sharp edges.

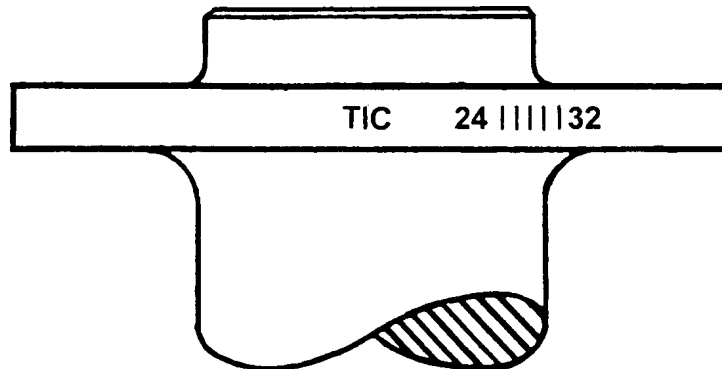
Magneto timing that is set utilizing these incorrect marks will advance timing by a maximum of three degrees.

**INCORRECT CRANKSHAFT FLANGE TIMING MARKS
FIGURE 2**

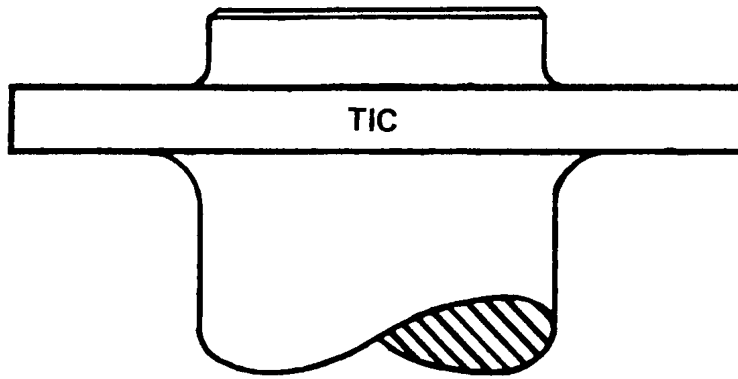
**REWORKED CRANKSHAFT FLANGE TIMING MARKS
FIGURE 3**

5. Apply a thin film of aluminum color, enamel spray paint to the buffed area. Allow sufficient time for the paint to dry. Reworked crankshaft flange timing marks will appear as illustrated in Figure 3.
6. Install the propeller and associated parts in accordance with the airframe manufacturers instructions.
7. Verify and set magneto timing as indicated in TCM Service Bulletin SB94-8.
8. Make a log book entry as to compliance with this service bulletin.
