TELEDYNE CONTINENTAL® AIRCRAFT ENGINE **SERVICE BULLETIN**

SB97-5

SUBJECT: INSTALLATION OF FLANGED TYPE FRONT MAIN BEARINGS

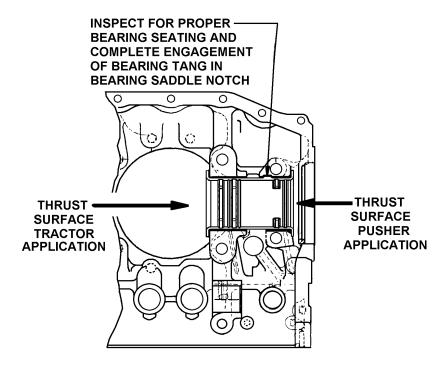
FIGURE 2. THRUST SURFACES

When installing any bearing insure that the bearing saddle and bearing back are clean, free of any oil and that no debris will be trapped between the bearing back and bearing saddle. Flanged front main bearings must be positioned in the bearing saddle so that the thrust flange is firmly seated against the machined thrust surface of the bearing saddle.

The thrust surface is the surface that absorbs the load of the crankshaft during engine operation. Figure 2.
