SERVICE INFORMATION LETTER
Contains Useful Information Pertaining To Your Aircraft Engine

SIL 04-9

SUBJECT: IO240B13B Manifold Valve Replacement, Heat Isolation Modifications and Throttle Body Modification.

PURPOSE: To reduce heat on the engine fuel system components and enhance idle stability

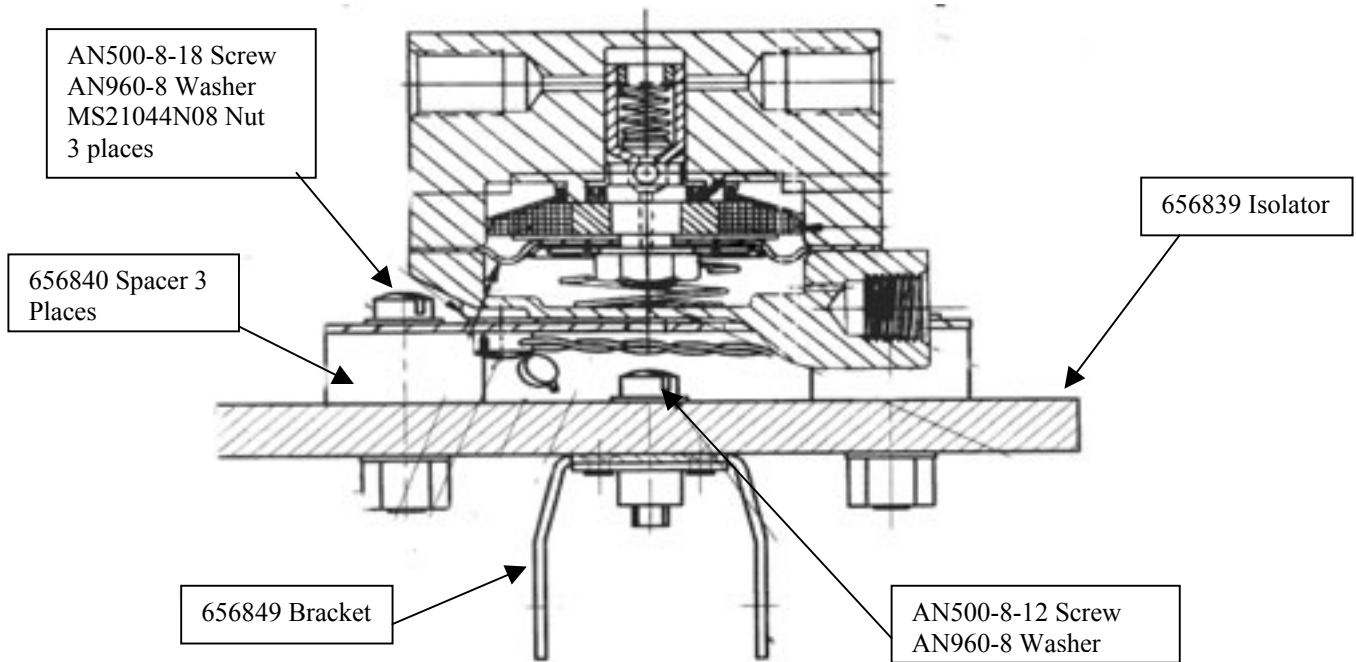
FIGURE 1

Manifold Valve and Heat Isolator Assembly

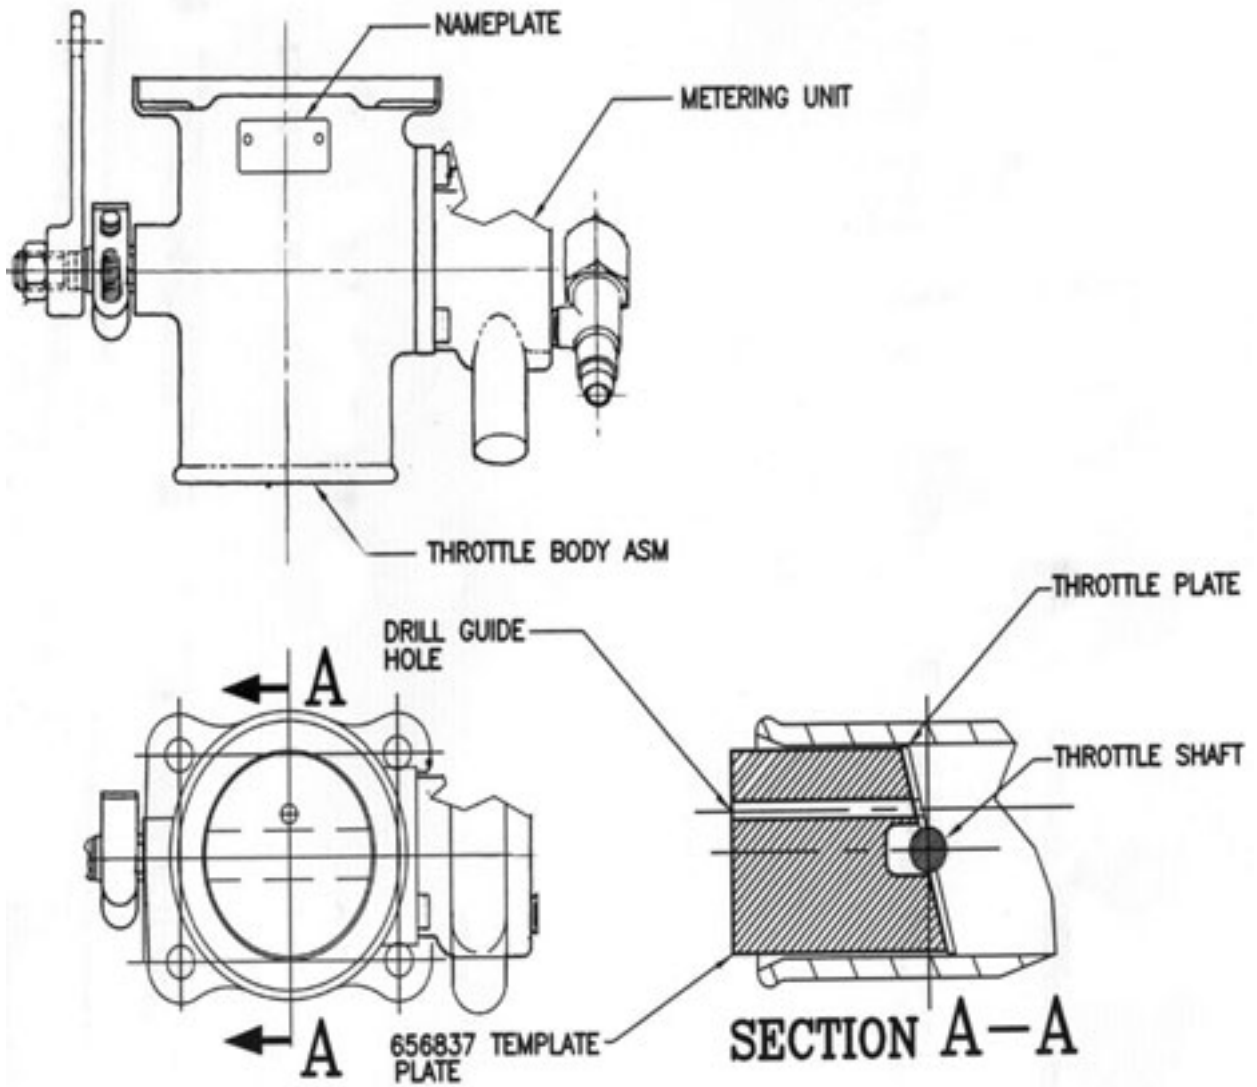
FIGURE 3
THROTTLE PLATE MODIFICATION

In order to further enhance engine idle characteristics, Teledyne Continental Motors has introduced a modification to the throttle plate located in the fuel injection system Throttle and Control Assembly. This modification utilizes a drill guide template to allow precise placement of a hole in the throttle plate.
