TELEDYNE CONTINENTAL[®] AIRCRAFT ENGINE
SERVICE INFORMATION LETTER

Category 5
SIL05-6A

SUBJECT: IO-240-B SERIES PRODUCT UPGRADES

PURPOSE: To provide an overview of product upgrades necessary to upgrade IO-240-series engines to current production configuration.

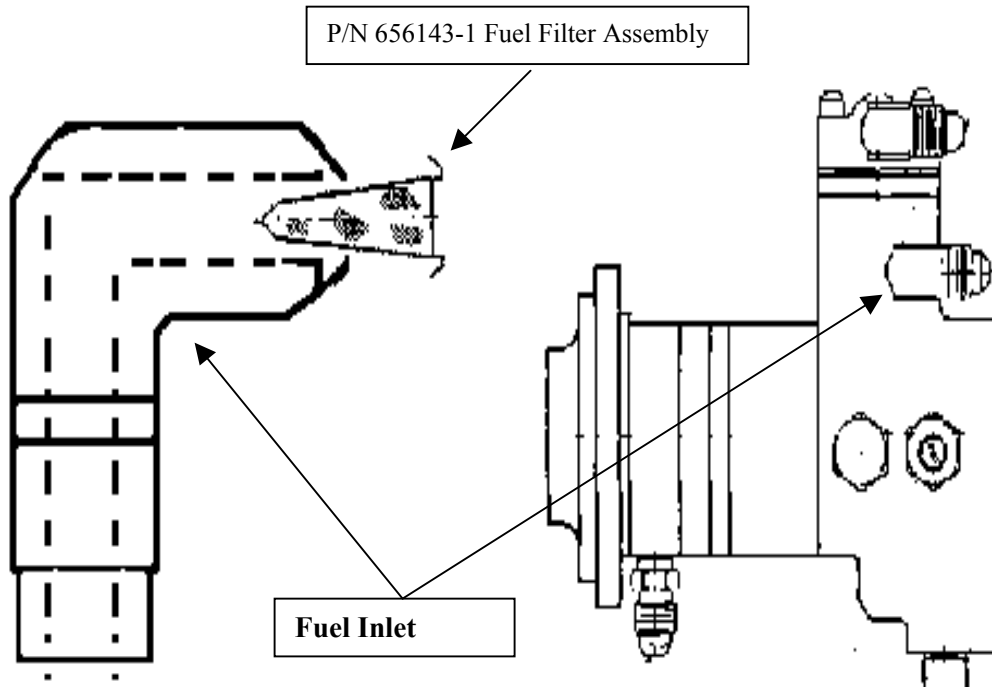
FIGURE 1
P/N 656143-1 FUEL PUMP INLET FILTER INSTALLATION

In order to enhance the aircraft fuel filtration system, DIAMOND AIRCRAFT has requested the optional installation of an additional fuel line filter screen at the engine driven fuel pump inlet fitting. Installation of the fuel pump inlet filter is recommended by Teledyne Continental Motors. Screen P/N 656143-1 is available from Diamond Aircraft or a TCM Authorized Distributor.

- (g) Insert the P/N 656143-1 fuel filter element into the fuel inlet fitting. Ensure that the fuel filter flange seats against the fitting flare. Reference Figure 1.

- (i) Remove the protective cover from the fuel pump inlet fitting and insert the P/N 656143-1 fuel filter element into the fuel inlet fitting. Ensure that the fuel filter flange seats against the fitting flare. (Reference Figure 1.)
