TELEDYNE CONTINENTAL<sup>®</sup> AIRCRAFT ENGINE  
**SERVICE INFORMATION LETTER**  
 Contains Useful Information Pertaining To Your Aircraft Engine

**SIL06-4**

**SUBJECT: FADEC SYSTEM HEALTH STATUS ANNUNCIATOR INDICATIONS**

AFFECTED: IOF-240-SERIES

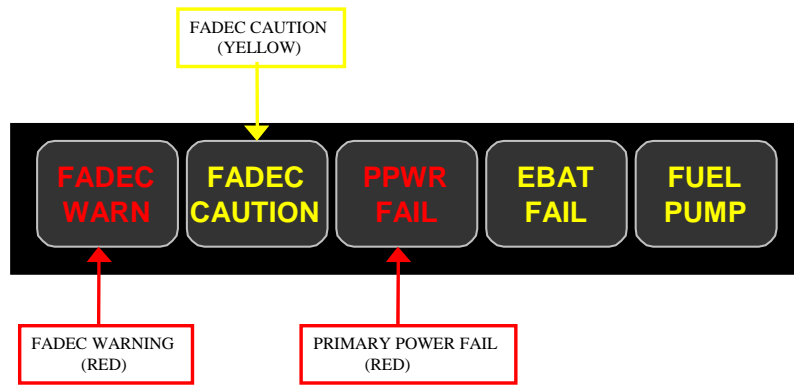
**FIGURE 1**  
 HEALTH STATUS ANNUNCIATOR PANEL

Teledyne Continental Motors (TCM) has received reports from the field of momentary Light Emitting Diode (LED) indications on the FADEC System Health Status Annunciator panel. These occasional, flickering indications most commonly occur on the FADEC CAUTION, FADEC WARNING, or PPWR FAIL LEDs. (Reference Figure 1)

TCM has reviewed this issue and found that noted momentary indications (flicker) of the FADEC WARN, FADEC CAUTION or PPWR FAIL LEDs are not safety issues and do not require pilot actions. TCM is currently working on software enhancements to address this issue.

**Persistent and steady LED indications of over 10 seconds or any other indications of abnormal engine operation may indicate potential propulsion system issues and must not be ignored. For any LED indication of over 10 seconds the specified Pilots Operating Handbook procedures must be followed.**
