CONTINENTAL MOTORS® AIRCRAFT ENGINE
SERVICE INFORMATION LETTER

CATEGORY 5
SIL15-8

- SUBJECT:** Front Mounted Alternator Bracket Assembly Inspection
- PURPOSE:** To provide inspection instructions for specific front mounted alternator bracket assembly (P/N 657046).
- COMPLIANCE:** During the next maintenance event and every 100-Hour/Annual Inspection, whichever may occur first for bracket (P/N) 657046, Revision A or earlier).
- MODELS**
- AFFECTED:** IO360-ES and L/TSIO360-RB utilizing front mounted alternator bracket assembly (P/N) 657046, Revision A or earlier)

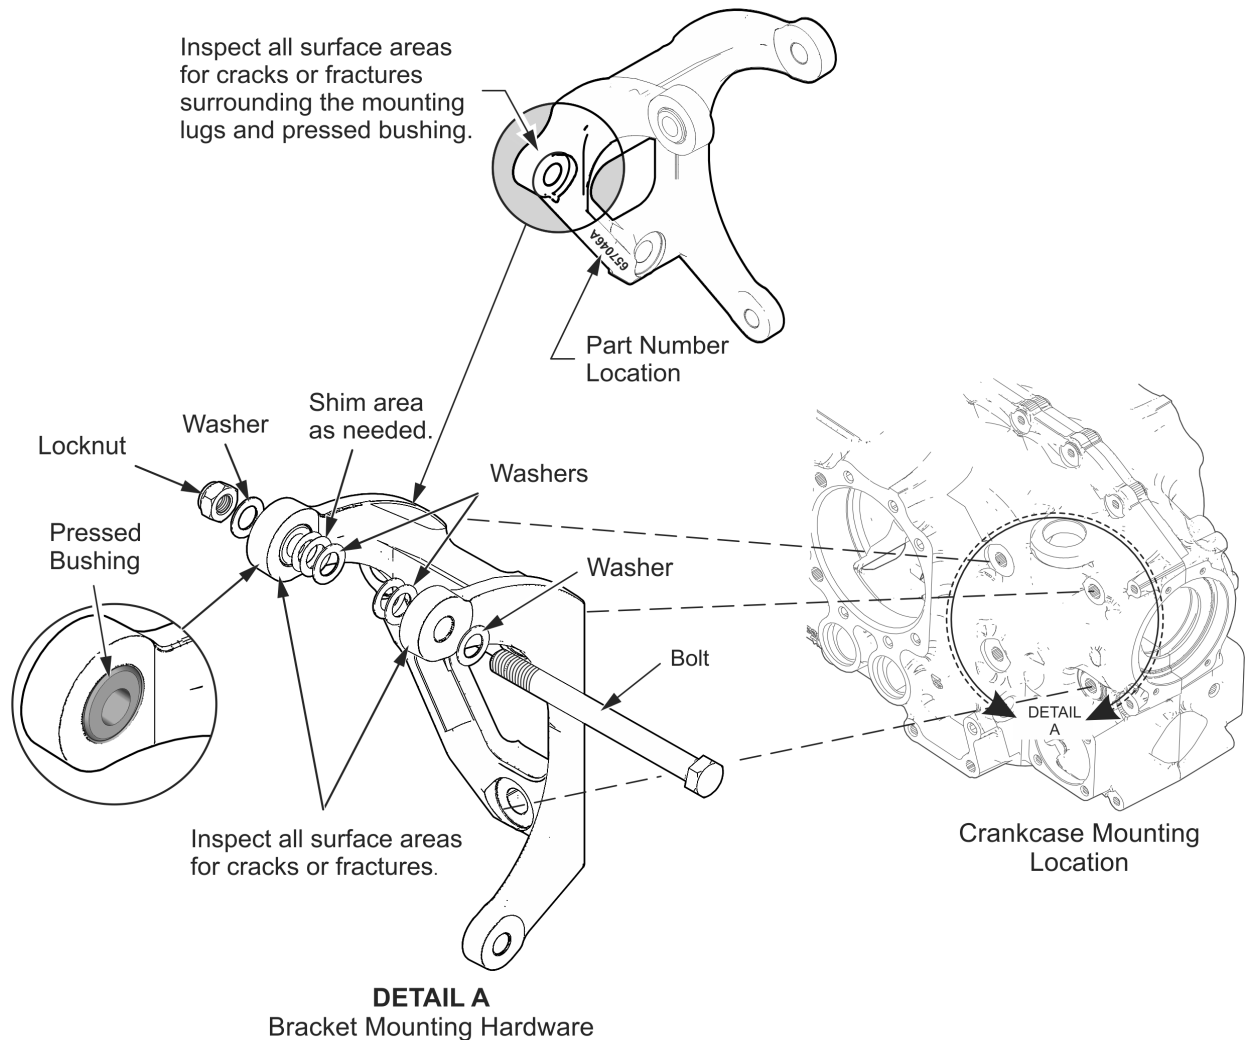
Figure 1. Bracket Assembly Inspection Area, typical

Field reports indicate isolated instances of cracks found in the forward upper alternator mounting flange and crankcase mounting areas of the front mounted belt-driven alternator bracket assembly (Part Number (P/N) 657046, Revision A or earlier).

Recent analysis and testing indicates the force required to move the bushing can be higher than the force required to bend the two upper mounting flanges to close the gap between the alternator boss and the upper bracket flanges.

1. Remove the belt-driven alternator according to the instructions in the engine Maintenance and Overhaul Manual.
2. Inspect the alternator, drive sheave, brace, and bracket assembly for physical damage.
3. Perform a visual inspection using a minimum 10x magnifier and bright light source on the cast aluminum bracket to verify the areas surrounding the mounting lugs and pressed bushing are not cracked or fractured (see Figure 1).
 - a. If the components are serviceable, install the belt-driven alternator with new shims, washers and lock nut according to the instructions in Section IV, "BRACKET ASSEMBLY INSTALLATION," on page 3.
 - b. If any of the removed components exhibit physical damage or the 10x visual inspection indicates the bracket assembly is cracked, obtain the necessary replacement parts and install according to the instructions in the primary ICA.

1. Remove the front mounted belt-driven alternator and alternator bracket assembly (P/N 657046),
2. Visually inspect all surface areas of the bracket to determine serviceability,
3. Reinstall the alternator bracket assembly (P/N 657046) and the front mounted belt-driven alternator, if serviceable, or replace with a serviceable replacement, according to the enhanced instructions in this service document.

This Service Document reduces the maximum allowable gap to less than 0.010 inches and installs additional shims (P/N 658616-3, 0.010 inches) at the aft location of the alternator pivot bolt. Additional shims assist the alignment between the alternator sheave and drive sheave and fills the void between the alternator boss and the upper bracket assembly.

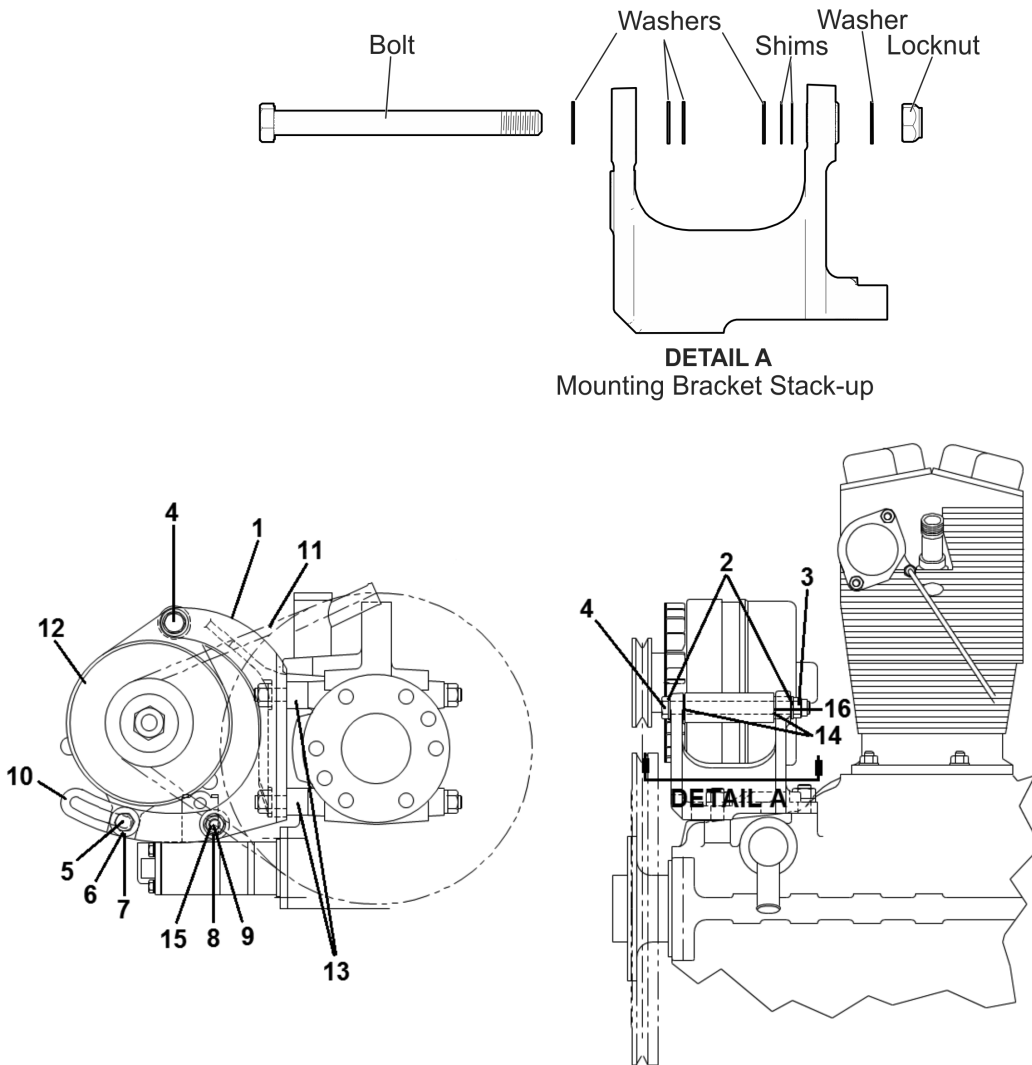
Figure 2. Front Mounted Alternator Assembly

CAUTION: Inserting an incorrect combination of washers or shims (Figure 2, items 14 and 16) at the upper mounting location of the bracket, may hinder the proper alignment of the alternator sheave and drive sheave.

1. Install the alternator (12) on the mounting bracket with the bolt (4) and new washers (2 & 14), shims (16) and locknut (3).
2. Align the adjustable brace (Figure 2) (10) bolt hole with the alternator outboard mounting hole. Loosely install the bolt (5) and the new lock washer (6) and washer (7) through the hole in the adjustable brace (10) into the alternator outboard mounting hole.

CAUTION: Each shim is nominally 0.010 inch. If the gap is greater than 0.010 inches, add a shim to fill the void.
 - b. If the pulley alignment tool indicates the sheaves are misaligned, remove the bolt (Figure 2) (4), washers (2 & 14), shims (16), and lock nut (3) from the alternator and bracket assembly (1) and use additional shims (16), as required, to fill the gap between the alternator and bracket assembly. When proper alignment between the two sheaves is achieved, proceed to next step.
 - c. With bolt (4) loose, fill any remaining void between the washer (Figure 2) (14) and the pressed bushing larger than 0.010 with shims (16) as needed.
