TELEDYNE CONTINENTAL[®] AIRCRAFT ENGINE

MANDATORY SERVICE BULLETIN

MSB 99-3C

SUBJECT: CRANKSHAFT INSPECTION

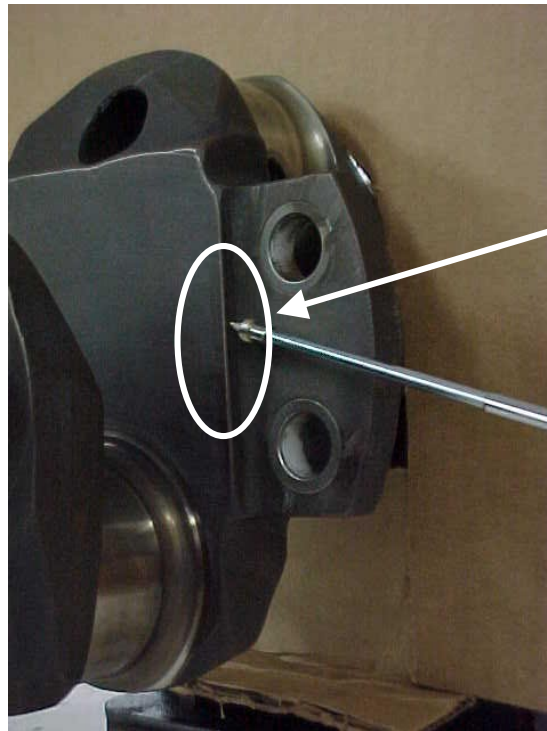
FIGURE 9. FOCUS INSPECTION IN THIS AREA

1. Using a soft shop towel dampened with solvent, remove any surface residue from the aft side of the number two and five crankshaft cheeks. The outboard area at the edge of crankshaft cheek next to the counterweight is the area to be inspected. See Figures 9, 10 and 11.
2. Using a flashlight and mirror or a borescope visually inspect the aft side of the number two and five crankshaft cheek for indications of a crack or mechanical damage. The inspection area is between the counterweight blade bushing holes at the chamfered edge of blade shoulder on

Chamfered edge of the aft side of number two and five crankshaft cheek centered between counterweight blade bushing holes on both sides

3. If the visual inspection does not clearly reveal a crack, perform an ultrasonic inspection of the aft side of number two and five crankshaft cheek in accordance with Section "B" ULTRASONIC INSPECTION.
4. If visual inspection reveals a crack the engine must be removed from service until repaired or replaced.

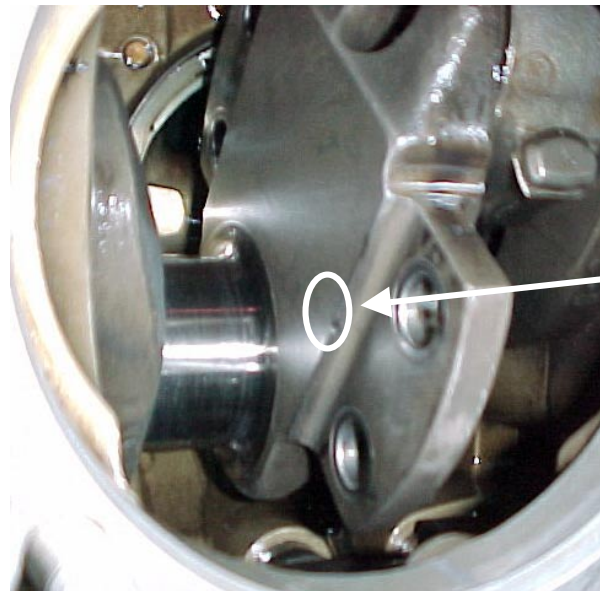
FIGURE 10. CRANKSHAFT IN INSPECTION POSITION #2 CRANKCHEEK CONNECTING ROD REMOVED

Inspect area of aft side of cheek between counterweight bushing holes at chamfered edge of blade shoulder on both sides

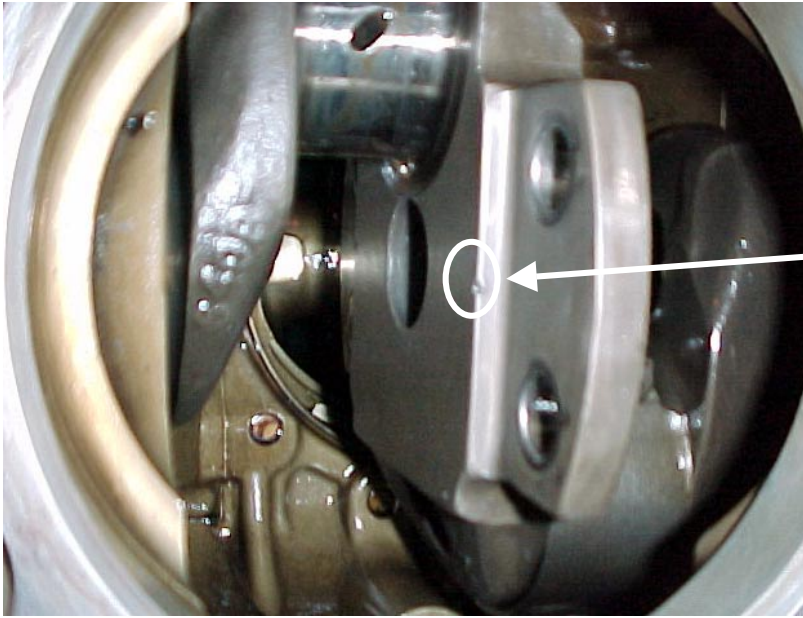
FIGURE 11. CRANKSHAFT IN INSPECTION POSITION #5 CRANKCHEEK CONNECTING ROD REMOVED

Inspect area of aft side of cheek between counterweight bushing holes at edge of blade shoulder on both sides
