TELEDYNE CONTINENTAL<sup>®</sup> AIRCRAFT ENGINE  
**SERVICE INFORMATION LETTER**  
 Contains Useful Information Pertaining To Your Aircraft Engine

**SIL08-10**

**SUBJECT: Precision Airmotive, LLC SIL RS-88. RSA5, RSA10 Servo inspections of Hex Plug Gasket**

## SUBJECT: Inspection of Regulator Hex Plug on RSA-5 and RSA-10 Fuel Injection Servos.

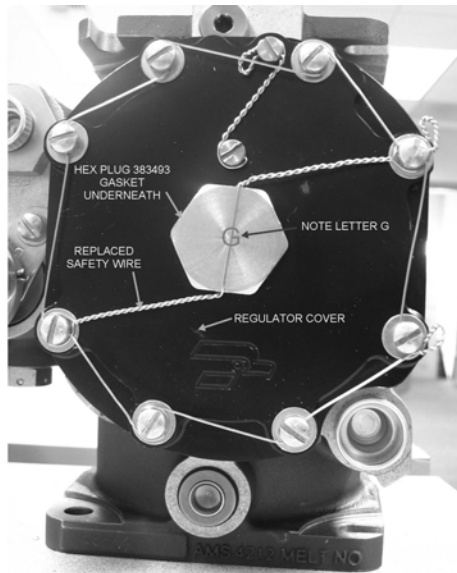
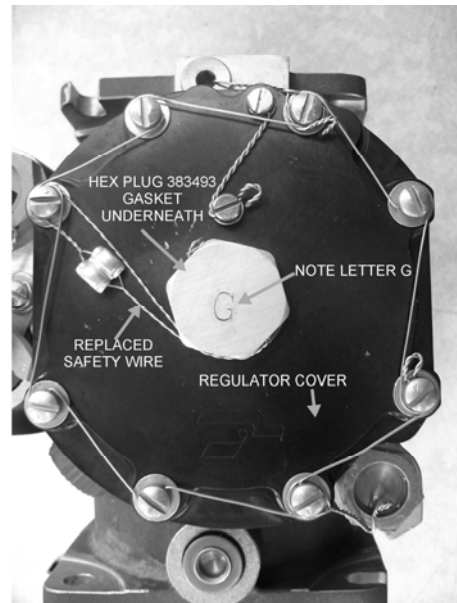
- A. EFFECTIVITY: This Service Information Letter is applicable to all RSA-5 and RSA-10 servos which do NOT have a “G” marked on the regulator hex plug (see photograph page 2.).

- C. DETAILED INSTRUCTIONS: If your aircraft has an RSA-5 or RSA-10 fuel injection servo that is NOT marked with a “G” on the regulator hex plug, during each annual or other periodic inspection (but at least annually) the regulator hex plug on the fuel injection servo should be inspected to verify that it is not loose. The regulator hex plug is a 1” brass hex plug on the large round cover on the side of the fuel injection servo. (See photograph page 2.)

6. Stamp or scribe the letter “G” onto the face of the hex plug as shown in the sample photos. This shall be done with the plug removed from the servo. DO NOT stamp the plug with it installed in the servo.

8. The hex plug must be safety wired with .015 thru .025 inch diameter wire to the regulator cover as shown in the photos below. The wire shall pass thru the plug such that it pulls the plug in the tightened direction and does not rest on the corners of the hex on the plug (it is acceptable to wrap under the corners of the hex plug). These photos are just two examples of acceptable safety methods. Other safety wire methods such as those described in FAA AC 43-13-1B (or latest revision) are also acceptable.
