TELEDYNE CONTINENTAL[®] AIRCRAFT ENGINE

MANDATORY SERVICE BULLETIN

MSB 99-3C

SUBJECT: CRANKSHAFT INSPECTION

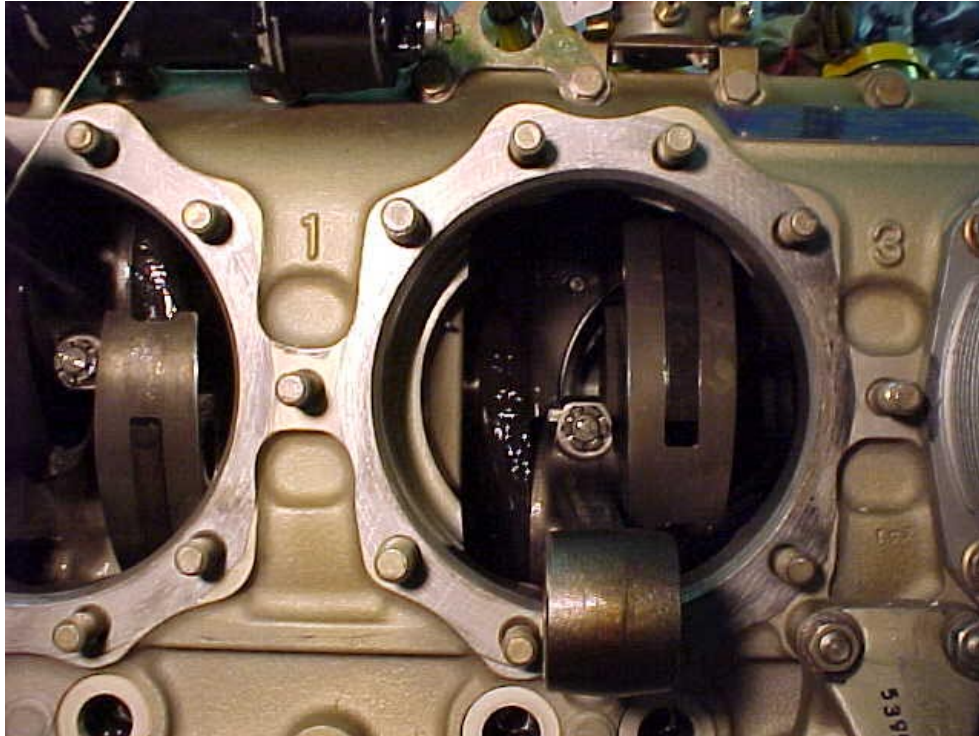
FIGURE 1. CONNECTING ROD IN POSITION FOR REMOVAL

7. Position the connecting rod to be removed (number one or number three) at or near top center. See Figure 1.
Note: The 470, 520 and 550 series engines may have connecting rod nuts secured with cotter pins or they may have Spiralock nuts which do not have cotter pins. When removing Spiralock nuts, you may find it necessary to tighten the nut slightly to release the self-locking feature.

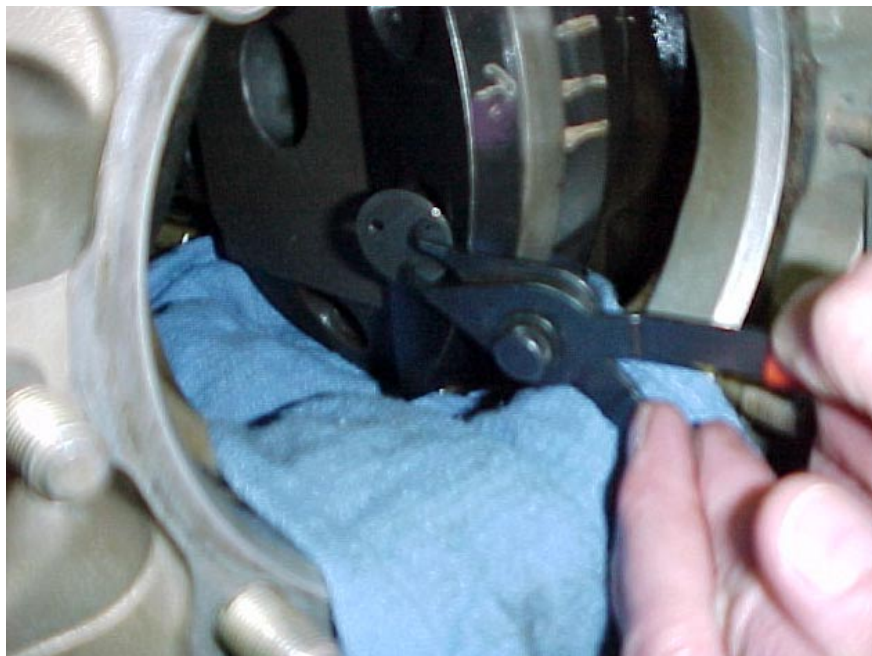
FIGURE 2. REMOVING COUNTERWEIGHT RETAINING PLATES

10. Position the crankshaft so that the rearward retaining rings and plates of a counterweight on the number two crankshaft cheek can be removed. Using a pair of snap ring pliers, remove and discard two retaining rings. Using a long, blunted tip awl and ball peen hammer tap the retaining plates to loosen them. Remove retaining plates with a pair of 90° offset snap ring pliers, a scribe with a hook fashioned into its end or a retrieval magnet. See Figure 2. Discard the retaining plates. Using a retrieval magnet, remove the counterweight pins. See Figure 3. Document the pin positions. They must be placed back in the same position from which they were removed.

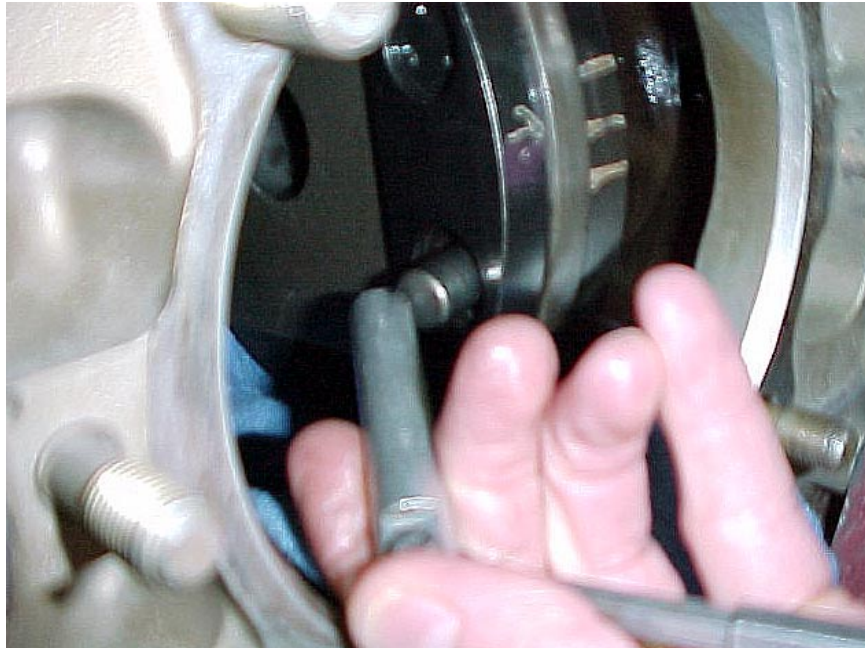
FIGURE 3. REMOVING COUNTERWEIGHT PINS

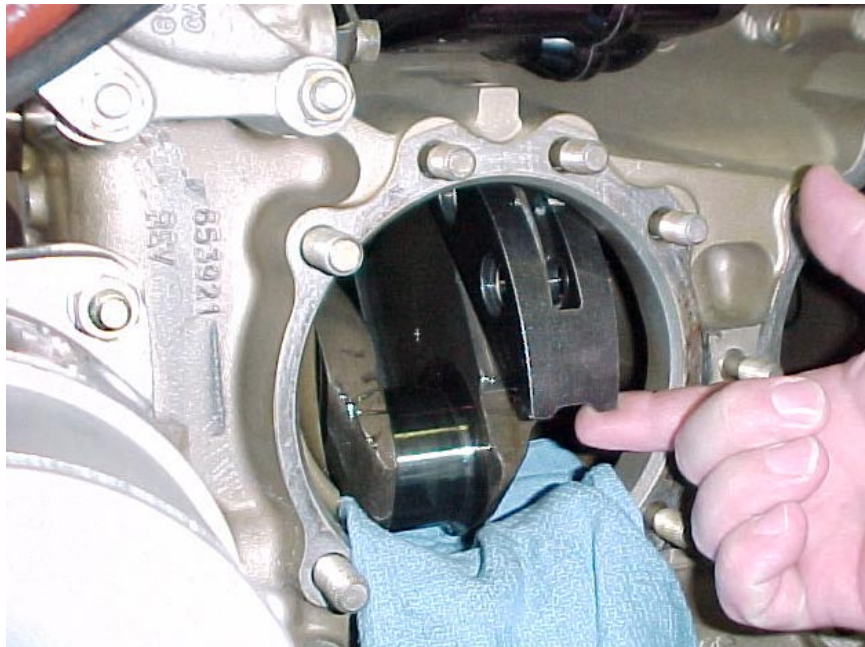
FIGURE 4. STARTING COUNTERWEIGHT THROUGH CYLINDER OPENING

11. Looking from the rear of the engine forward, turn the crankshaft in the counterclockwise direction far enough that the lower end of the counterweight can be started out through the cylinder opening by hand. See Figure 4. Now turn the crankshaft in the clockwise direction and remove the counterweight. See Figures 4, 5, 6 and 7.
12. Using the procedure in steps 10 and 11 remove the remaining counterweight on the number two crankshaft cheek and remove the two counterweights on the number five crankcheek.
13. Some counterweights may not clear the crankcase and cannot be removed. If so, position as shown in Figure 8 for the inspection.

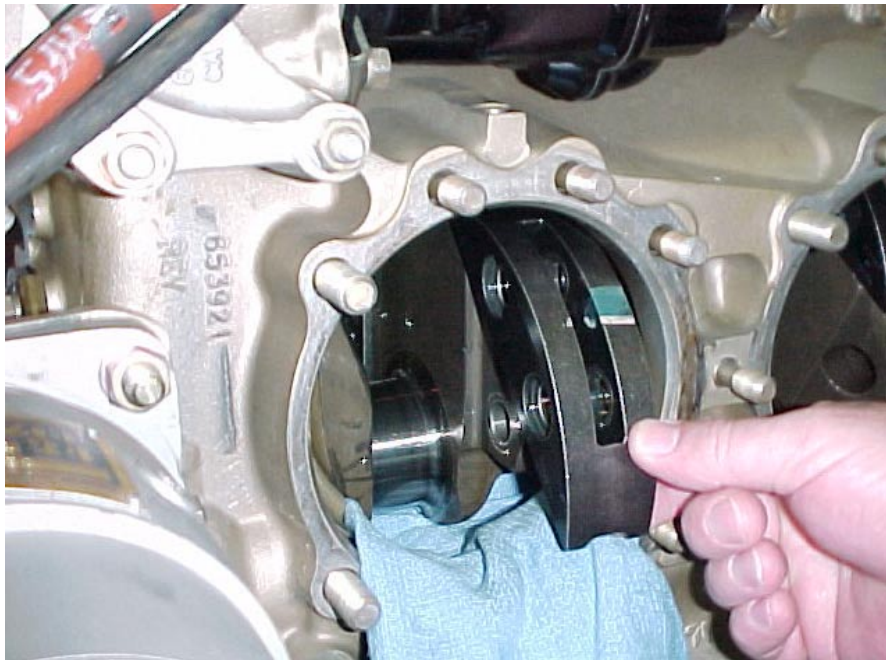
FIGURE 5. GUIDING COUNTERWEIGHT THROUGH CYLINDER OPENING

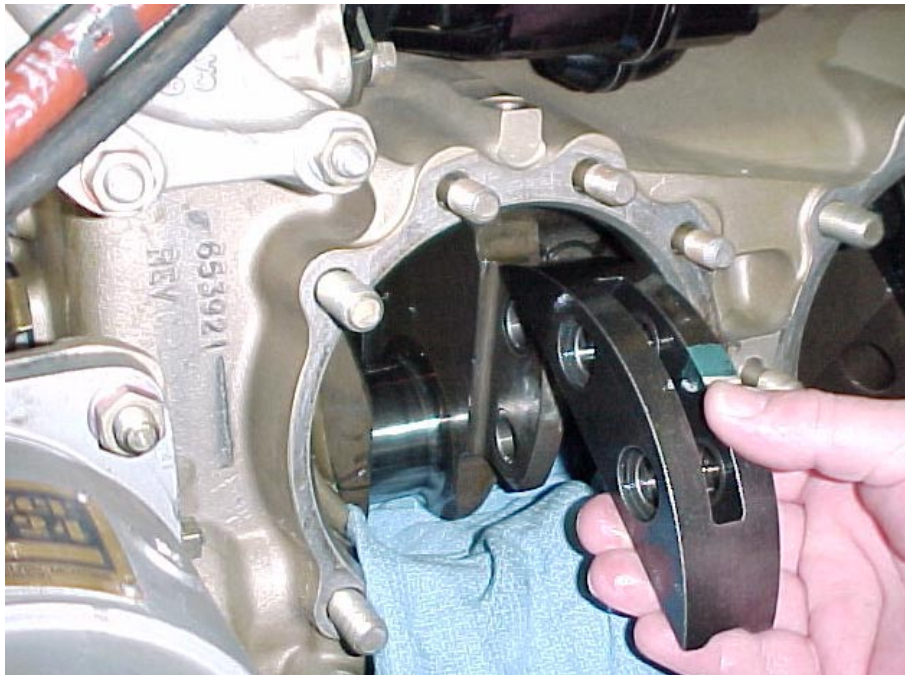
FIGURE 6. COUNTERWEIGHT REMOVED

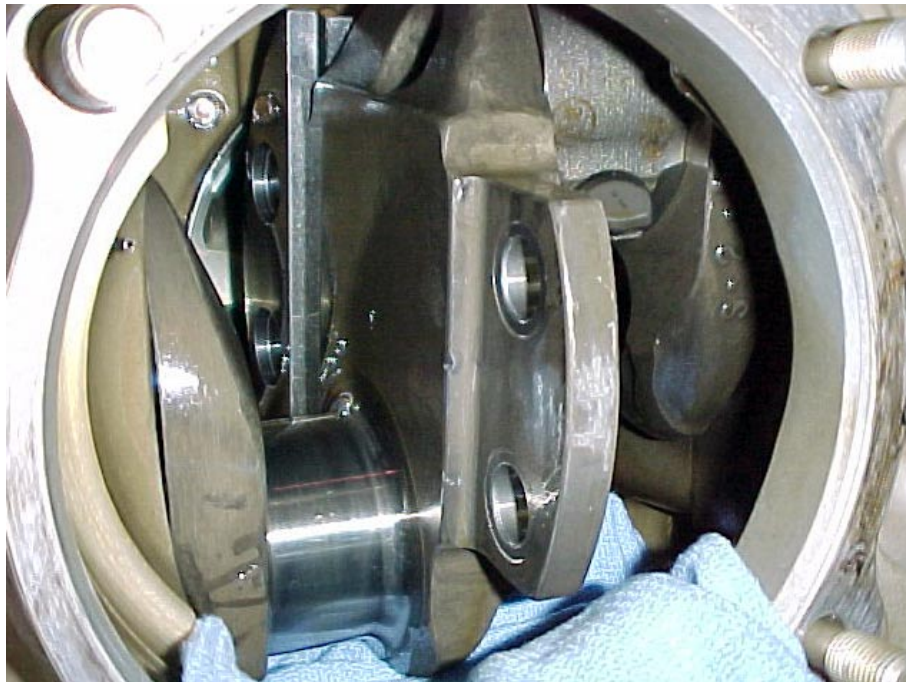
FIGURE 7. CRANKSHAFT COUNTERWEIGHT BLADE

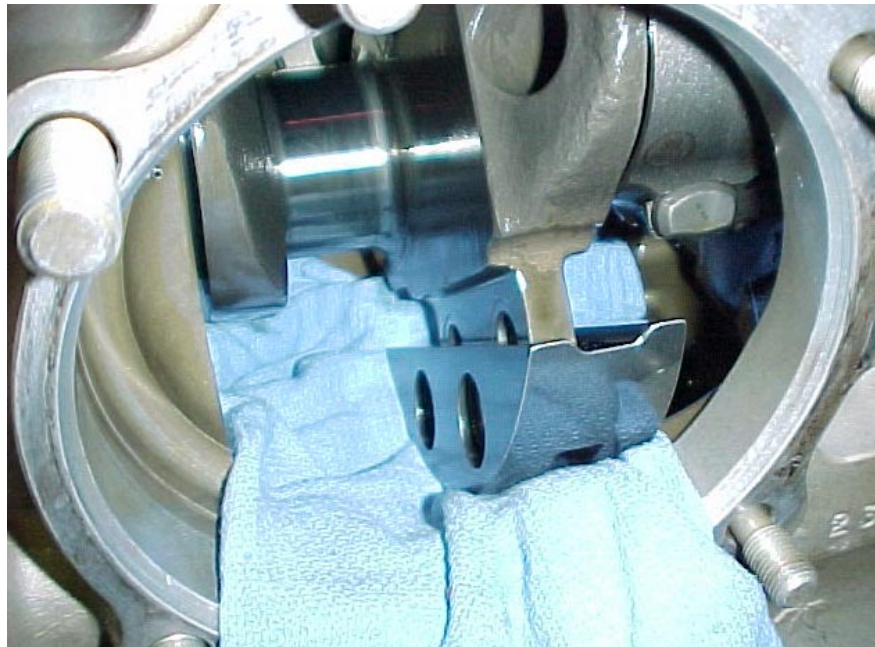
FIGURE 8. CRANKSHAFT COUNTERWEIGHT PARTIALLY REMOVED

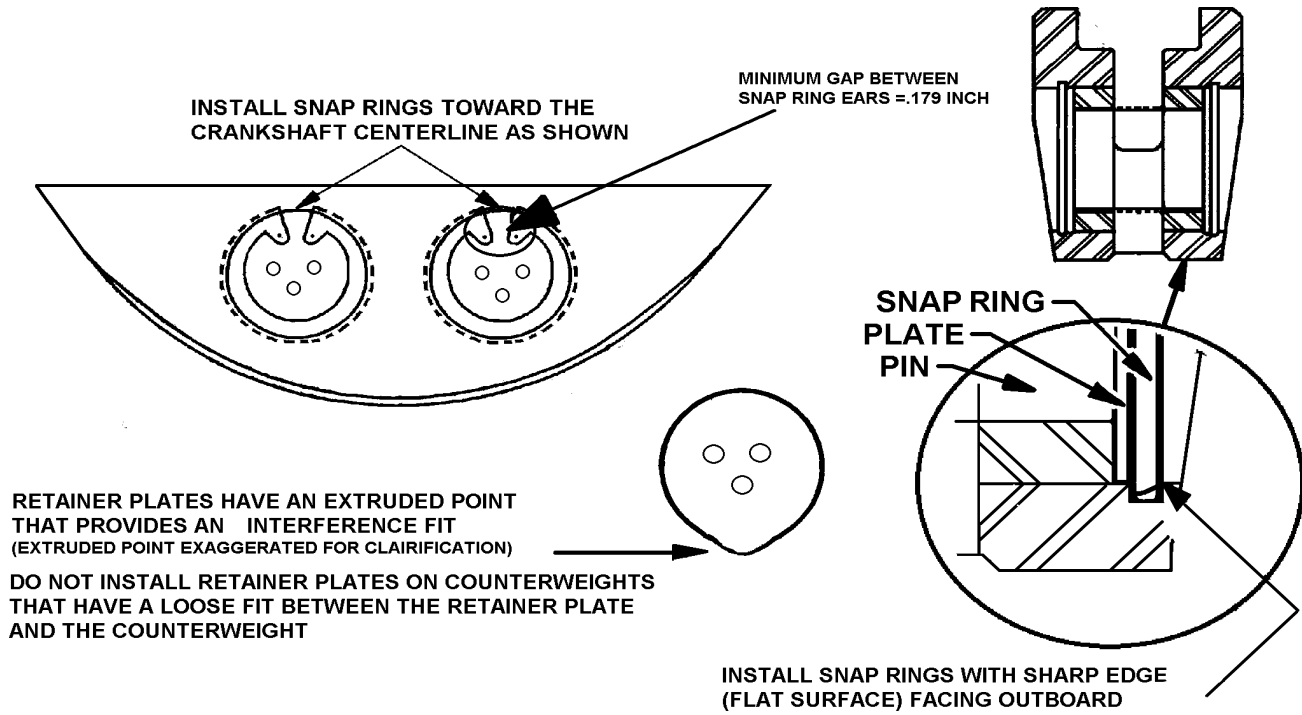
FIGURE 12 COUNTERWEIGHT INSTALLATION

Note: Use an inspection mirror and flashlight to verify that the entire circumference of each snap ring is fully seated in the counterweight snap ring groove.

The snap rings, plates and pins must be installed as shown in Figure 12. "Counterweight Inspection, and Installation."

Do not use plates that have a loose fit. Failure to properly install counterweight retaining plates and snap rings may result in engine damage and possible failure.

5. Visually and dimensionally inspect all snap rings to insure the snap ring is correctly installed and fully seated in its groove. See Figure 12.
6. Apply 50-weight Aviation grade oil to the number one and three crankshaft connecting rod journals.
7. Position the number one and three connecting rod caps with bearing insert and bolts installed (position number facing up) on the respective crankshaft connecting rod journals.
8. Install the number one and three connecting rods, with bearing insert in place, on the respective crankshaft connecting rod journal while supporting the connecting rod cap and bolts.

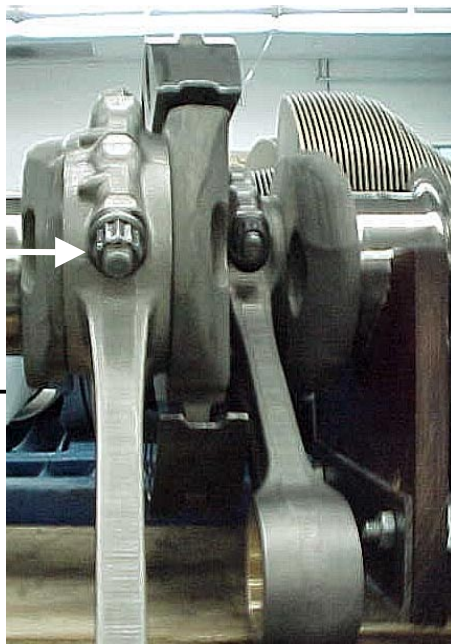
12 point spirallock nut.

FIGURE 13. TWELVE POINT SPIRALLOCK NUT

For connecting rods using either P/N 643215 or P/N 654490 self-locking connecting rod nut (Spirallock nut), torque to the value specified in Table 1. See Figure 13.

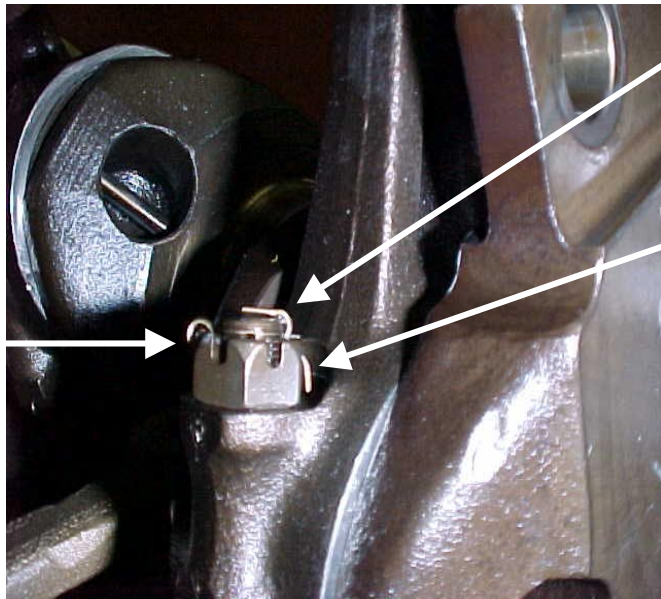
Seat head of cotter pin into nut castellations

Bend one leg of cotter pin up and back toward cotter pin head. Trim leg so that it ends in the center of the bolts diameter.

Bend the other leg down toward the nuts base and trim leg so that it ends half the distance between the bottom of the nut castelation and nut base.
