MANDATORY SERVICE BULLETIN

MSB94-4G

SUBJECT: STARTER ADAPTER SHAFTGEAR AND CRANKSHAFT GEAR INSPECTION

AFFECTED: All GTSIO-520 and GIO-550 engine models.

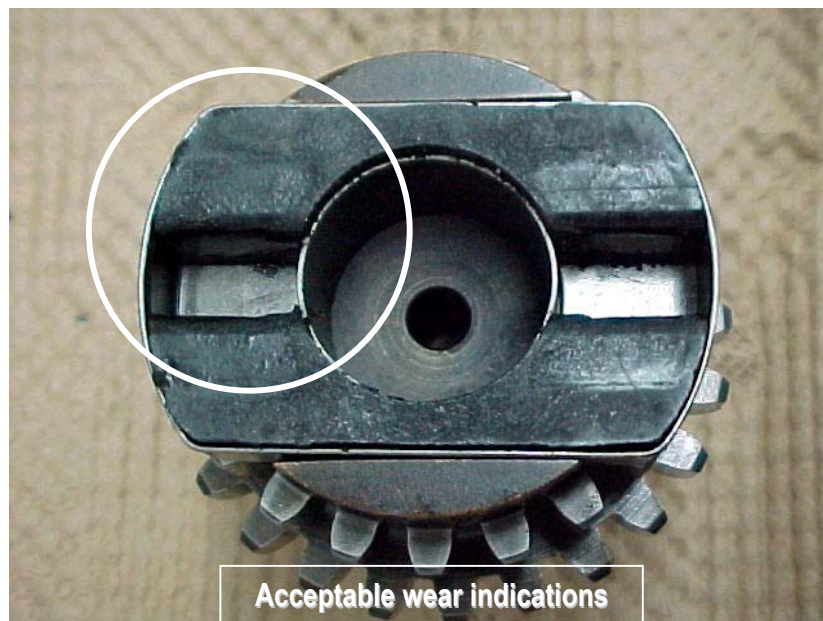
FIGURE 1. MAGNETO DRIVE RUBBER BUSHINGS

6. Remove the left and right magneto drive gear assemblies.
7. Inspect the left and right magneto drive rubber bushings for damage. Refer to Figure 1 on page 3 for typical wear signatures.

If there is no visible damage to the magneto rubber drive bushings, lubricate the magneto drive gear needle bearing with Molyshield Grease, P/N 656817, and reinstall the left and right magneto drive gear assemblies and magnetos in the reverse order of removal. Time the magnetos to the engine in accordance with the instructions detailed in the latest revision of TCM Mandatory Service Bulletin MSB94-8. Torque attaching hardware to the values specified in the latest revision of TCM Service Bulletin SB96-7.

If there is visible damage to the magneto rubber drive bushings, proceed with step number 8.

Replace the magneto drive rubber bushings with new bushings. Insure that the rubber bushings are installed with the beveled edge facing out. Lubricate the magneto drive gear needle bearing with Molyshield Grease, TCM P/N 656817, and reinstall the left and right magneto drive gear assemblies and magnetos in the reverse order of removal. Time the magnetos to the engine in accordance with the instructions detailed in the latest revision of TCM Mandatory Service Bulletin MSB94-8. Torque attaching hardware to the value specified in the latest revision of TCM Service Bulletin SB96-7.

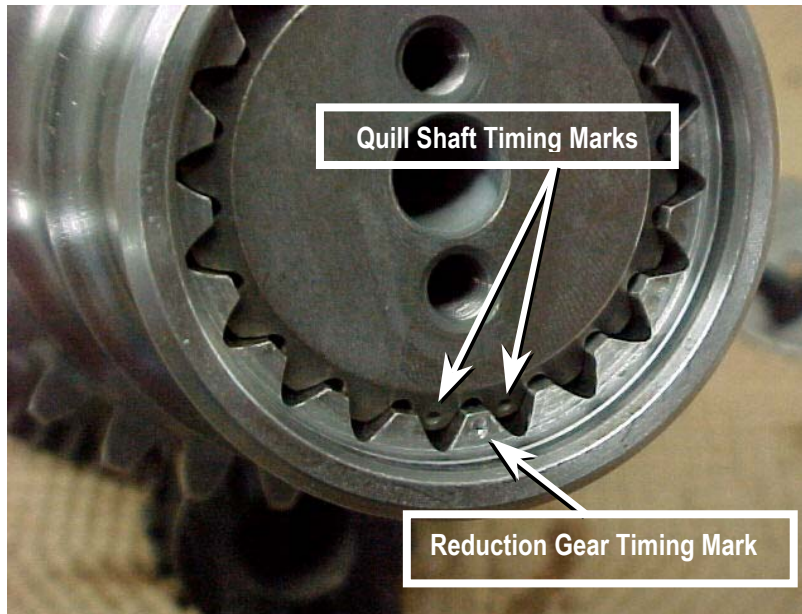
FIGURE 2. QUILL SHAFT & REDUCTION GEAR TIMING MARKS

NOTE.... Ensure that the quill shaft is installed with the two timing marks on the quill shaft straddling the timing mark on the reduction gear. See Figure 2 on page 4. Install retaining plate and torque bolts to 90 – 110 in. lbs. Install snap ring in propeller drive gear snap ring slot with flat side facing out. Ensure snap ring is completely seated. See Figure 3 on page 5.

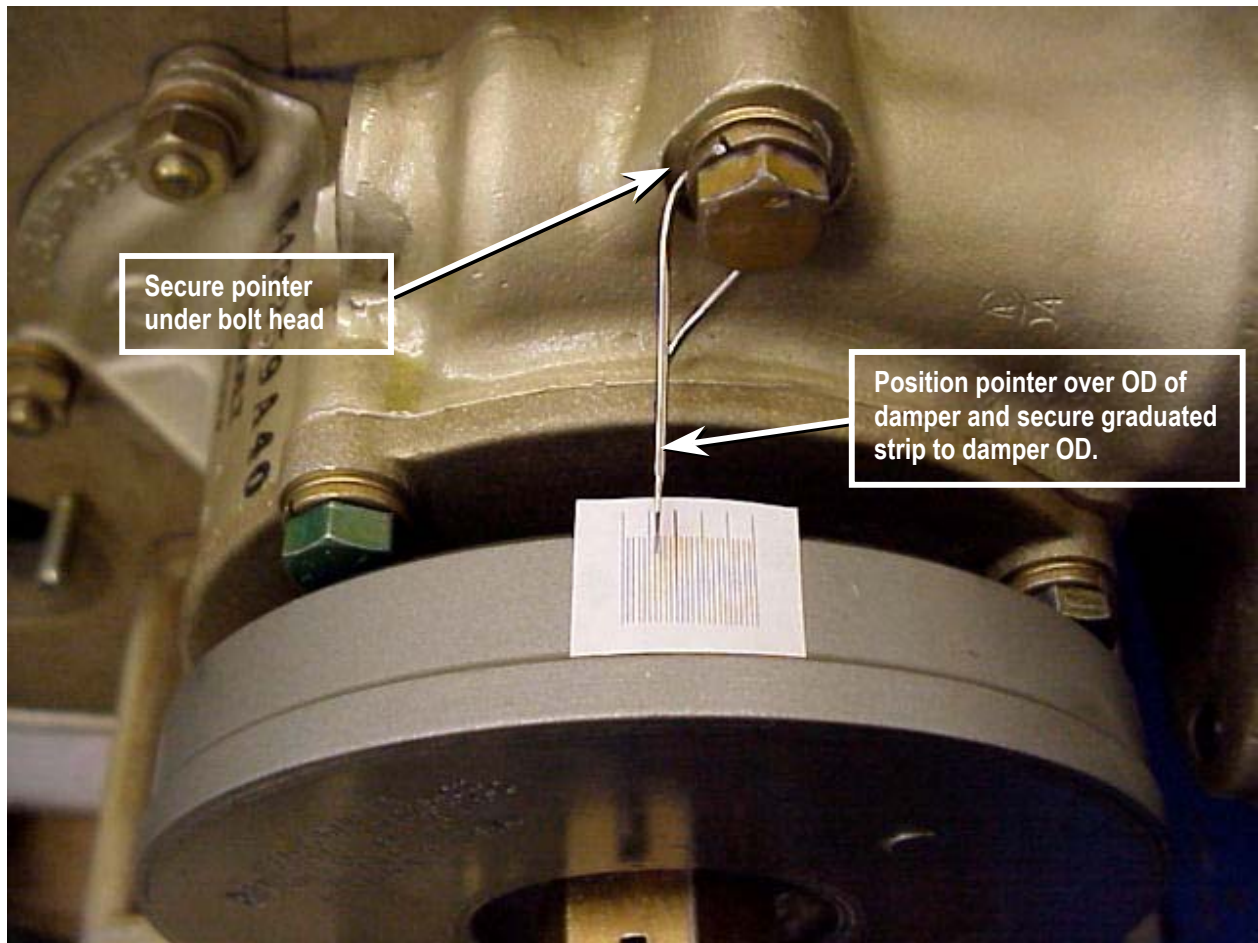
FIGURE 4. DAMPER SHAFT BACKLASH MEASUREMENT

6. Loosen the starter adapter bolt at the 12 o'clock position. Secure the looped end of the wire under the bolt head and position the pointer over the center of the viscous damper OD. Moderately snug the bolt to hold the pointer stationary. See Figure 4 on page 7.

7. Fabricate a measuring strip 1 inch long, graduated in .02 inch increments, from heavy paper stock. Then secure the measuring strip to the previously cleaned OD of the viscous damper using Scotch Tape. See Figure 4 on page 7.

8. Measure the amount of gear backlash by rotating the viscous damper by hand through its full range of travel. Record the maximum gear backlash measured and remove the graduated measuring strip.

11. If none of the four measurements exceeded .06 inches, proceed to step 13.
12. If any of the four measurements exceed .06 inches, remove the starter adapter and perform the inspection specified in Part 3, "VISUAL INSPECTION PROCEDURE" section of this bulletin.

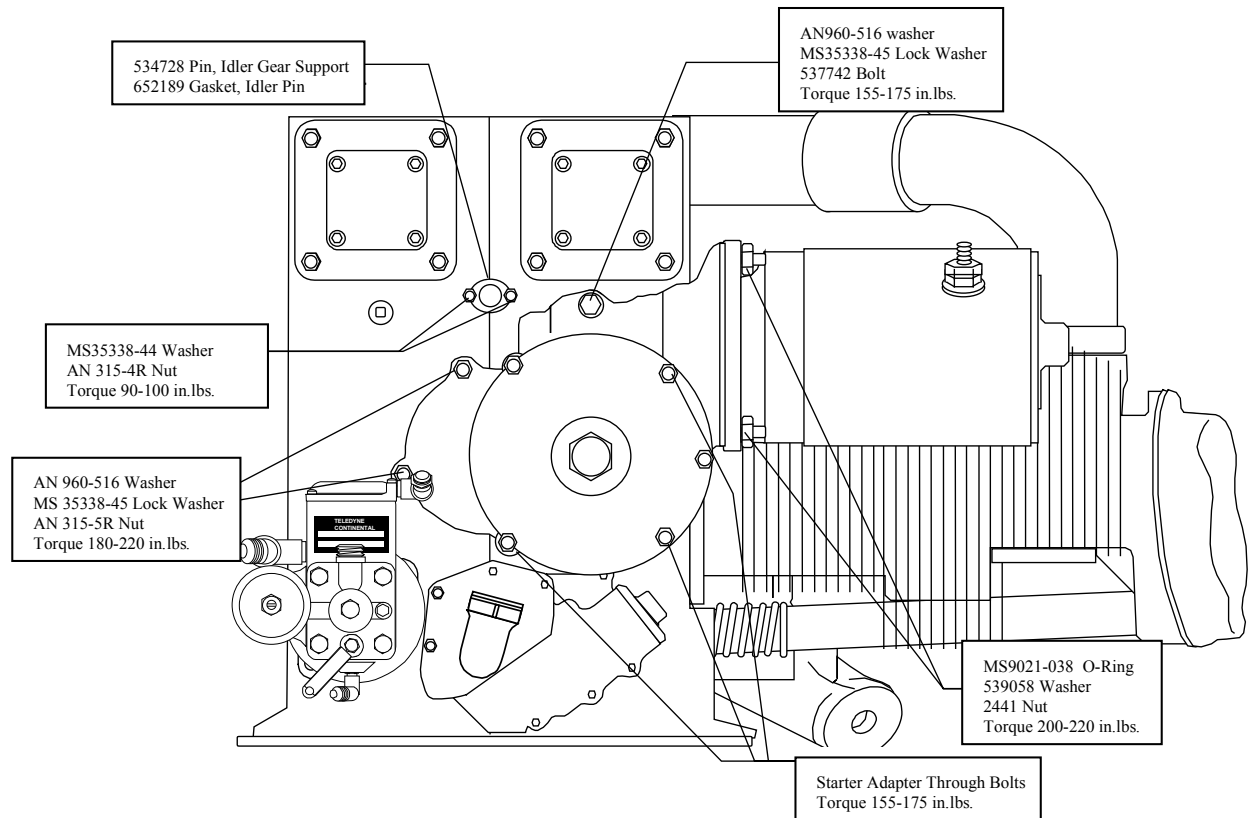
FIGURE 5. STARTER ADAPTER ASSEMBLY

2. Disconnect all spark plug leads and remove the lower spark plugs.
3. Remove the two nuts P/N 2441 and washers P/N 539058 that attach the starter to the adapter. See Figure 5 on page 8.

4. To remove the starter adapter from the engine, remove two sets of nuts P/N AN315-5R, lock washers P/N MS35338-45, and plain washers P/N AN960-516. Remove the top starter adapter bolt P/N 537742, lock washer P/N MS35338-45, and plain washer P/N AN960-516. Loosen the three starter adapter through-bolts located between the starter adapter housing and torsional damper that are positioned at the two, five and seven o'clock positions. Loosen each of these through-bolts until they contact the torsional damper. Pull the starter adapter away from the engine crankcase as far as possible. Repeat this procedure until the bolt threads are no longer engaged in the crankcase. See Figure 5 on page 8 for location of hardware.

11. Using a new gasket reinstall starter adapter in the reverse order of removal. Reinstall starter motor using new O-ring. Refer to Figure 5 on page 8 for attaching hardware torque values.

8. Using a new gasket reinstall starter adapter in the reverse order of removal. Reinstall starter using new O-ring in the reverse order of removal. Refer to Figure 5 on page 8 for attaching hardware torque values.

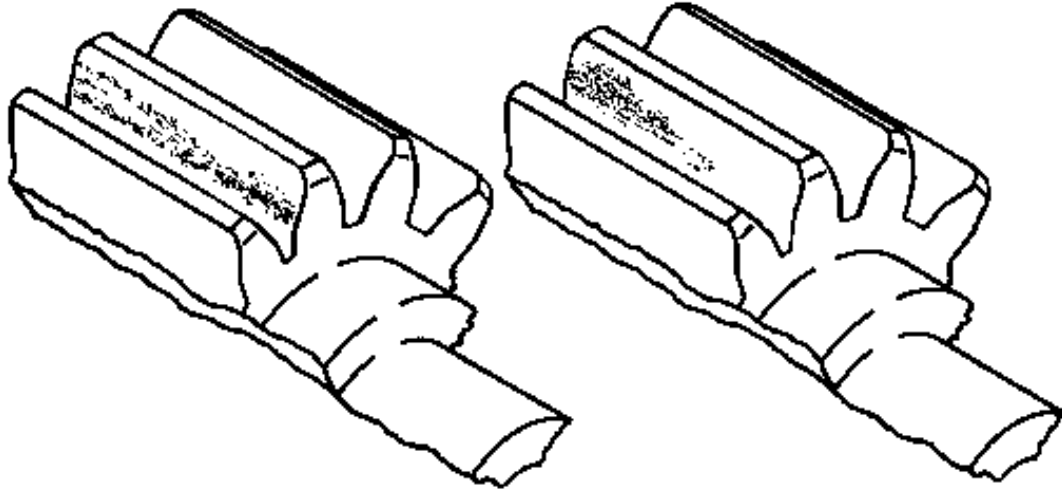
FIGURE 6

5. Remove the starter adapter from the engine. Using a clean, lint free cloth wipe the oil from crankshaft gear and starter adapter gear teeth to allow inspection.
6. Visually inspect the starter adapter shaft gear and crankshaft gear teeth using an inspection light and 10X magnifying glass for evidence of heavy spalling, pitting or wear that alters the gear tooth profile.
7. If the starter adapter shaft gear or crankshaft gear exhibits unacceptable tooth wear as indicated in Figure 6 on page 9, TCM service kit P/N EQ6642R must be installed prior to further flight. Proceed to Part 5 of this Mandatory Service Bulletin.

UNACCEPTABLE
HEAVY WEAR, SPALLING AND
PITTING FULL TOOTH WIDTH

UNACCEPTABLE
HEAVY WEAR, SPALLING AND
PITTING PARTIAL WIDTH

The crankshaft gear, starter adapter assembly and viscous damper must be replaced at the same time if the tooth wear of either gear is unacceptable in accordance with this bulletin.

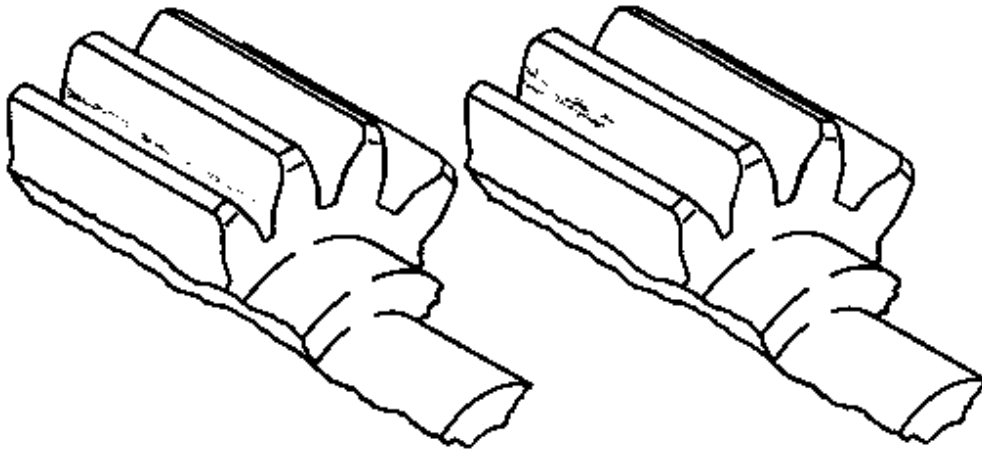
FIGURE 7

8. If the condition of the crankshaft gear and starter adapter shaft gear teeth are acceptable, as indicated in Figure 7 on page 9, they may be continued in service. Comply with the recurring inspections listed in the "COMPLIANCE" section of this bulletin.

ACCEPTABLE
LIGHT WEAR LINE, FULL TOOTH
WIDTH UP TO .01 INCH WIDE

ACCEPTABLE
MODERATE WEAR LINE, NO MORE
THAN 50% TOOTH LENGTH AND .05 INCH
WIDE

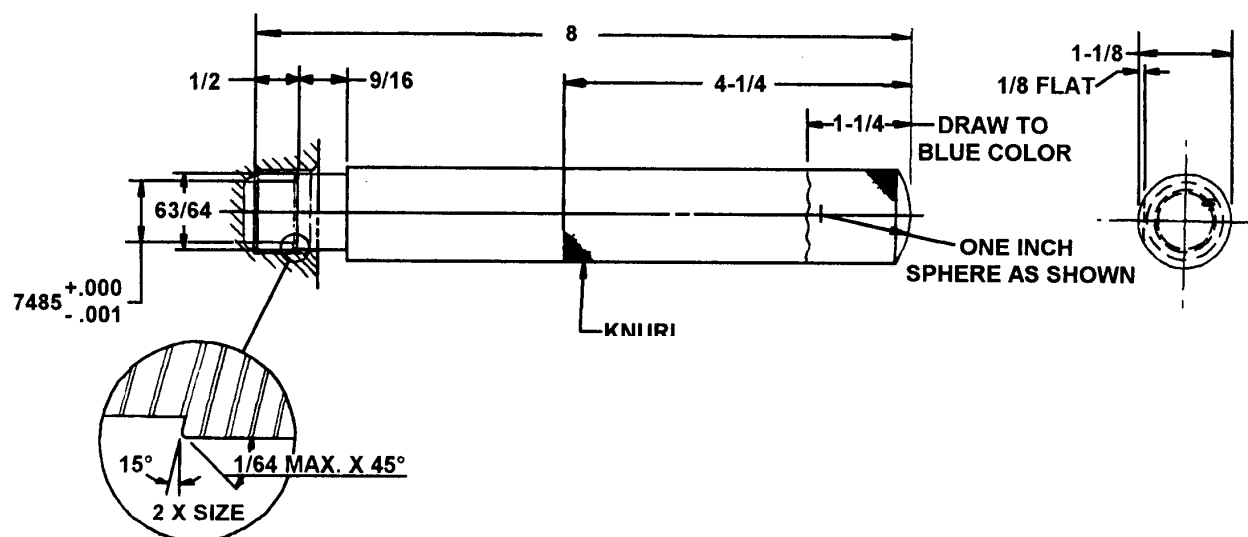
FIGURE 8. STARTER ADAPTER BUSHING INSTALLATION TOOL

4. To facilitate installation of bushing P/N 654472, place bushing on installation tool and submerge bushing in a container of Al-Co-Sol. Place the container of Al-Co-Sol with driver and submersed bushing in dry ice for 15 minutes prior to installation.
5. Install bushing into crankcase bushing bore using a bushing driver equivalent to the one shown in Figure 8 below. Ensure that bushing is firmly seated against the stop surface of the bushing bore. A bushing driver may be locally manufactured from SAE 6150, AISI S7, or equivalent round stock tool steel using the dimensions provided in Figure 8 on page 11.
